Australian Gold Mine Turns to CHEMCLAD & CeramAlloy to Save Pump Operating in 15% Hydrochloric Acid!

These photos are of a pump from a gold mine which was repaired by an ENECON Fluid Flow Systems Specialist in Australia.

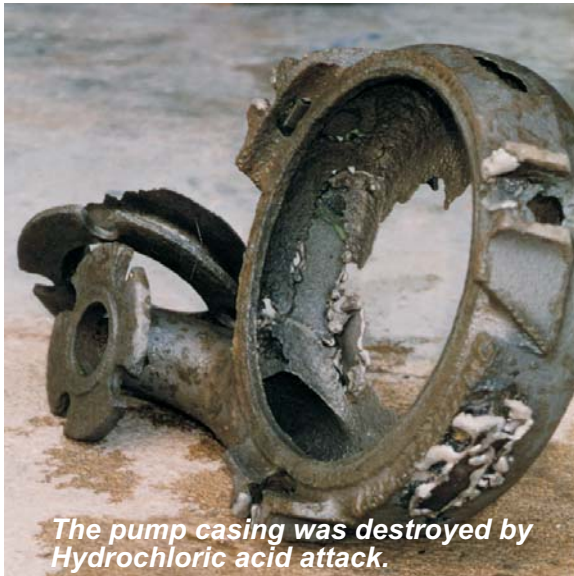
The pump casing was destroyed by Hydrochloric acid attack.

The pump was running in 15% Hydrochloric acid and, as you can see, it has been attacked from the outside as well as the inside!

This pump casing was repaired using

CeramAlloy CP+ and CL+, and CHEMCLAD XC, at a total cost of \$1,200. The entire repair took just 24 hours.
