Power Plant In The Philippines Chooses CHEMCLAD & CeramAlloy To Repair & Protect Critical FGD Pipeline

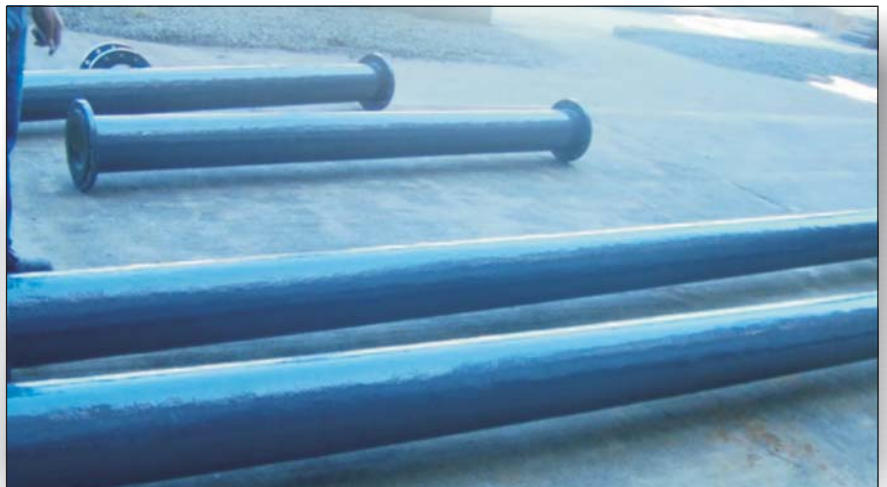
The make-up pipeline for the Flue Gas Desulfurization (FGD) section of this power plant in the Philippines was severely damaged by corrosion.

All components were first thoroughly prepared by grit blasting. An initial coat of CHEMCLAD SC was then applied to all surfaces.

CeramAlloy CP+[AC] was then applied to rebuild all the deeply pitted areas, followed by a final coat of CHEMCLAD SC to complete the application.
