## FLEXICLAD Repairs Cavitated Pump in Puerto Rico

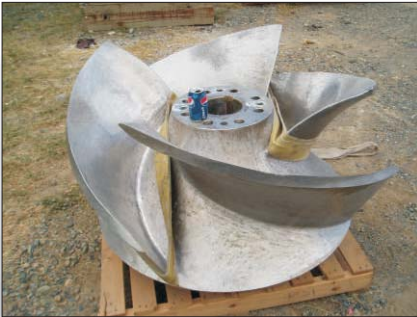
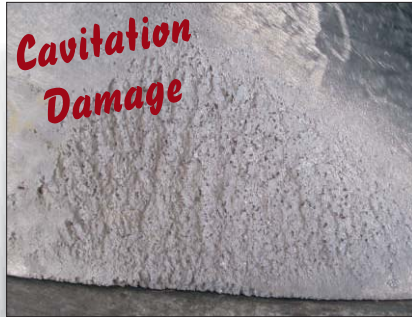
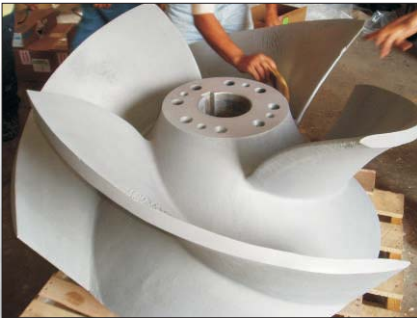
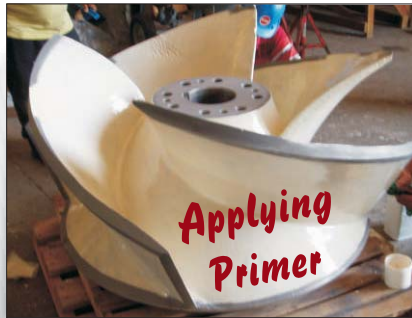
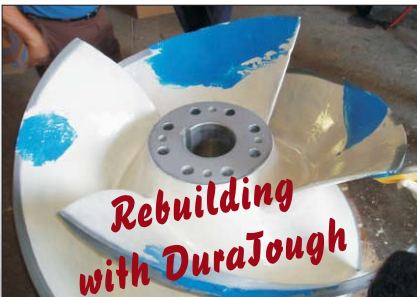
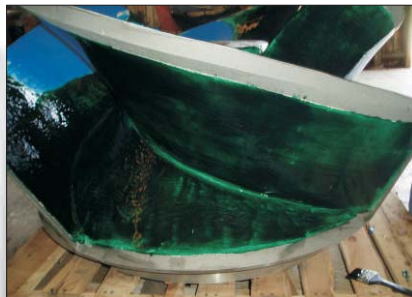
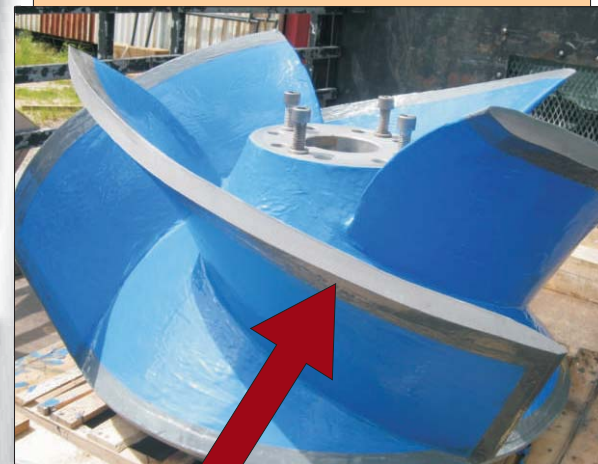
The stainless steel impeller of this large pump, located at a waste water treatment facility in Puerto Rico, was suffering from severe cavitation. The facility engineers needed a fast, reliable as well as cost-effective repair. The local ENECON Distributor was contacted to help find a solution.

In addition, **CeramAlloy CL+AC** was also used to protect the impeller's edges. **CeramAlloy CP+AC** and **CL+AC** were also used to rebuild and protect the pump casing which had significant corrosion damage.

It was decided that the impeller would first be prepared by grit blasting, followed by all cavitated areas being rebuilt with **DuraTough DP**.

The impeller was then protected from future cavitation damage with **DuraTough DL**.
