Oregon Paper Mill Repairs Damaged Chipper Disk With CeramAlloy... Savings Could Top \$100,000!

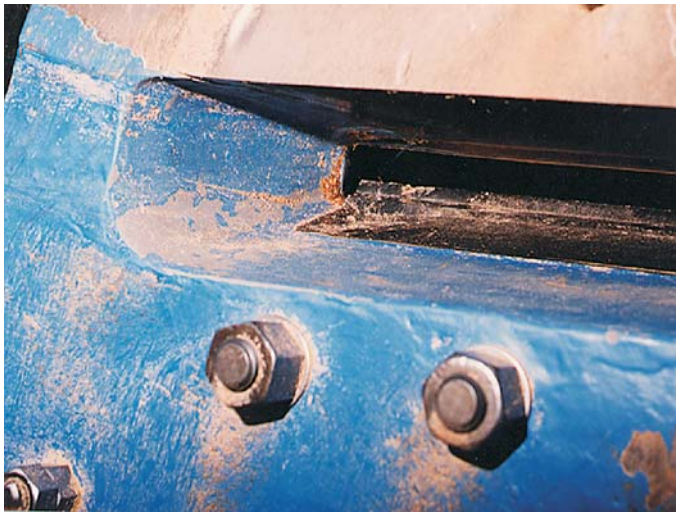
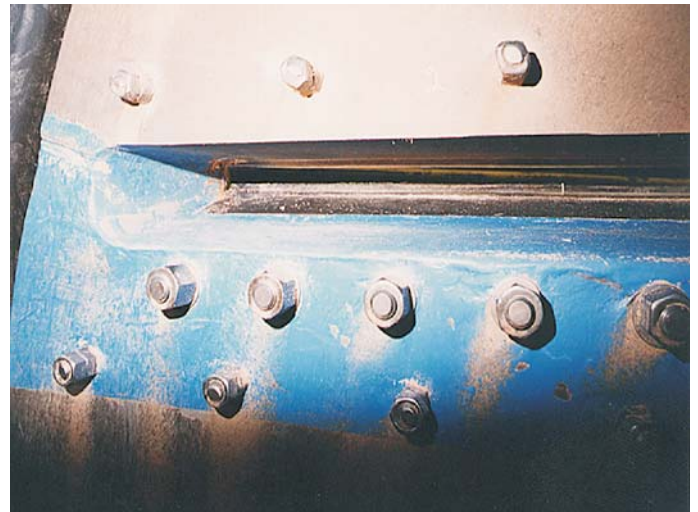
One year after repairs were made to all 8 pockets of a large (150+ inch diameter) chipper anvil, the enclosed photos were taken. The repairs involved rebuilding badly worn areas, which, if allowed to progress, would have threatened the structural integrity of the wheel. Replacement would have cost up to \$100,000 plus even more costly downtime

The ends of each

pocket had been eroded by about 2 inches, the shelf by $\frac{3}{4}$ inch, and the face by up to $\frac{1}{2}$ inch. Two kilograms of CeramAlloy CP+ were used to rebuild each pocket, followed by an overlay of CeramAlloy CL+ to protect the first eight inches of the face. Material costs were less than \$3,500, and labor consisted of two plant people, plus the ENECON Field Engineer, for 1-

In the pictures, wood residue shows as discoloration, especially on the face. The CL+ in those areas is virtually unaffected. The knives are changed daily by loosening the top two rows of studs with an impact wrench. The wrench has chipped pieces out of the face, but these do not progress beyond

the initial damage, and are not considered significant. Incidentally, the erosion is so severe that the steel nuts are worn round and must be replaced frequently!

1/2 days, which included surface preparation.
