Sea Water Ravages... **CeramAlloy Salvages** **Shipboard Evaporator**

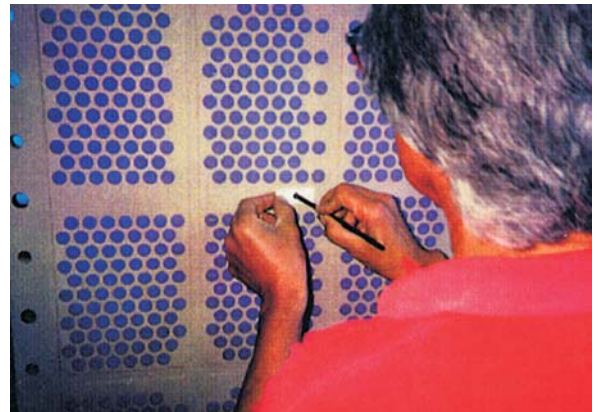
This evaporator from the Military Sealift Command vessel San Jose was found corroded and severely eroded - especially in the areas where the division bars joined the face of the tube sheet. The force of the rushing water actually forces these joints slightly apart, resulting in "water jetting" and increased erosion.

After thorough preparation, which included checking for residual salt contamination and exact measurement

of the "blast profile" (see top photo), CeramAlloy CP+ was first used to rebuild the deeply damaged areas, followed by the application of the CeramAlloy CL+.

"Imagineering" is often what makes a great application even better. In this case, the ENECON Engineer suggested the use of the DuraTough DP to create a perfectly formed and slightly compressible joint at each division bar/ tube sheet mating surface.

In this way, when the pressure of the flowing water force the end cover back, the DuraTough will "fill the void" and eliminate the adverse effects of the accelerated erosion due to water jetting.
