U.S. Navy Salvages Main Salt Water Circulating Pump on an Amphibious Assault Ship with CeramAlloy

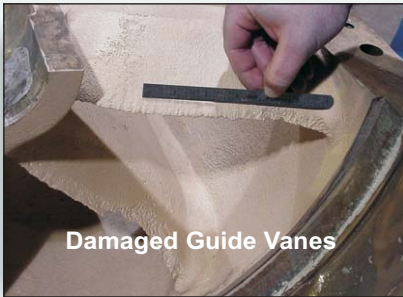
Damaged Guide Vanes

ENECON Hampton Road's Pier Side Rapid Availability Team (P.R.A.T) were recently called in to solve a severe erosion/corrosion issue on the main sea water circulating pump that feeds the main steam condenser on an LHD vessel. This class of ships carries helicopters, Harriers (vertical take-off jets), LCAC's (Landing Craft - Air Cushion hover crafts) as well as about 2,000 Marines and all their equipment. It is a key component of the U.S. Navy's amphibious assault arsenal.
