## South Florida Municipality Salvages "Hopeless" Pump Impeller with DurAlloy & CeramAlloy for Less Than Half of What a New Impeller Would Have Cost.

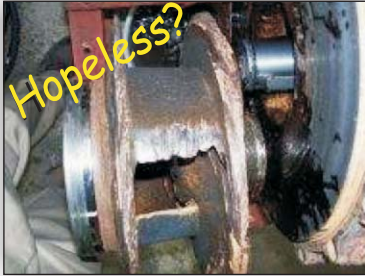
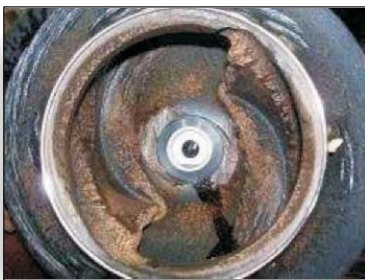
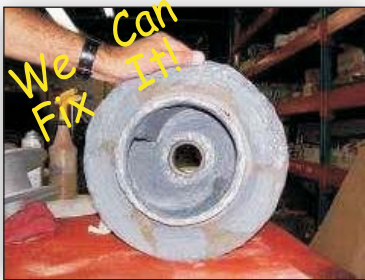
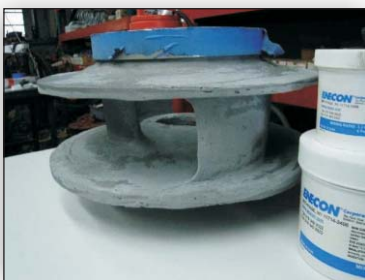
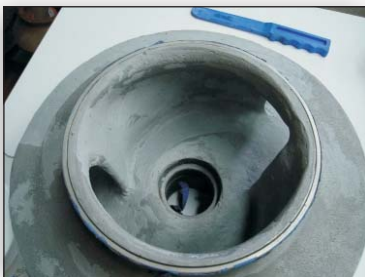
When they inspected one of these badly damaged impellers, the plant engineers thought that a repair was "hopeless". But the local ENECON Fluid Flow Systems Specialist said, "Not so fast." "We can fix it!"

The original size of the impeller was 295 millimeters. The damaged impeller was only 281 millimeters! Not only was the impeller very worn, but

the top and bottom flanges were out of round and uneven, as well. Because of its machinability, DurAlloy was first used to rebuild all the damaged areas back to original shape and contour.

Two coats of CeramAlloy CL+AC were then applied to completely resurface and protect the impeller and improve the pump's overall efficiency.
