DurAlloy Stops Critical SF-6 Gas Leaks

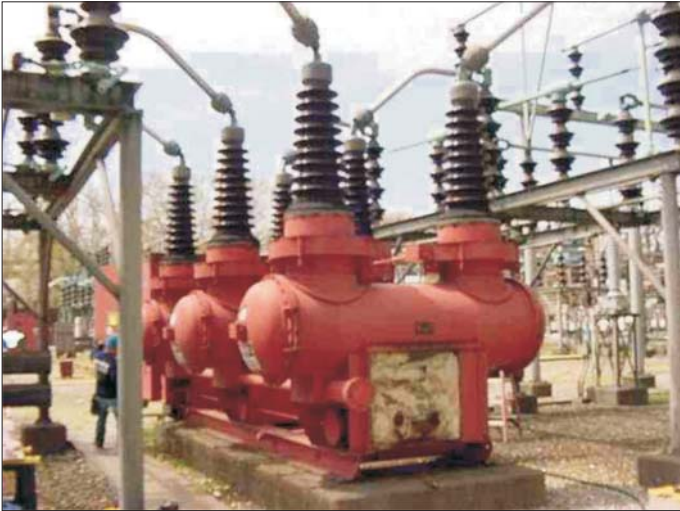
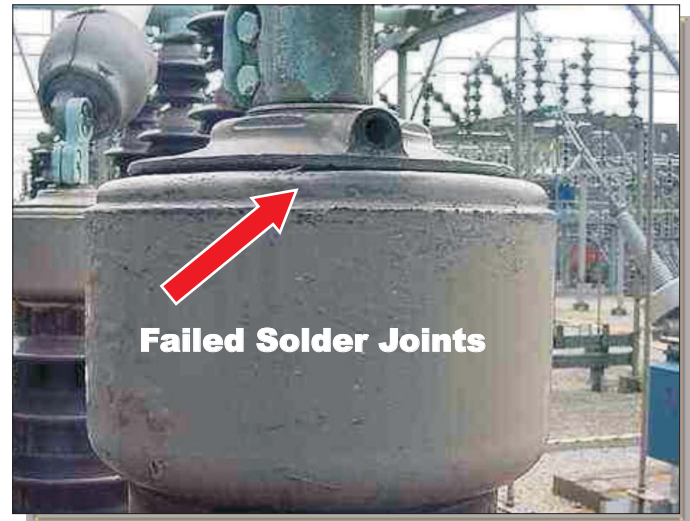
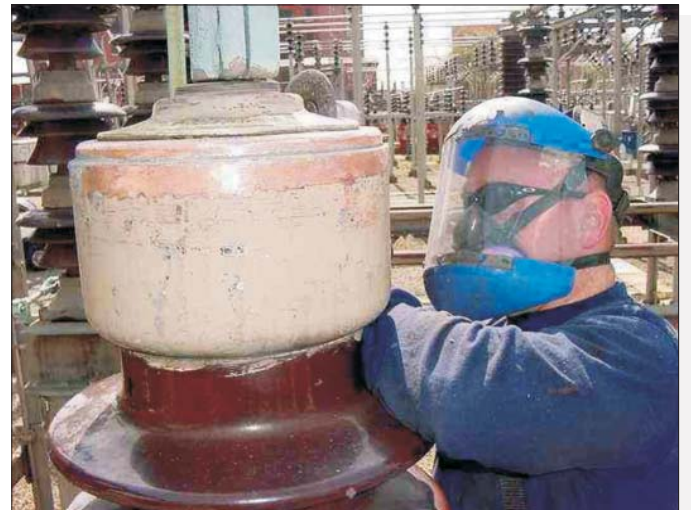
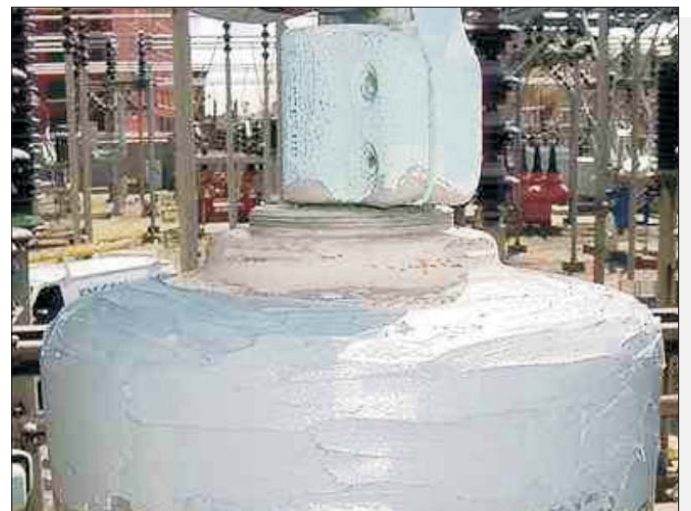
A major Northeastern U.S. utility company was experiencing SF-6 gas leaks on its substation breakers. Cracks in the old solder joints were causing this gas to leak from the insulator bushing caps. SF-6 gas has excellent cooling and insulation capabilities. However, SF-6 gas is an expensive and ozone-depleting gas so leaks are unacceptable.

First, the old solder and paint were stripped away from the bushing caps. After a thorough cleaning, DurAlloy was applied to completely seal the failed joints.
