DuraWrap Saves Main Influent Pipe at Waste Water Treatment Plant

- Location:** Northeastern U.S.
Problem: Corroded & leaking main influent pipe.
Solution: Repair leaks with *DurAlloy*; reclaim pipe with *DuraWrap Carbon Fiber Pipe Wrap System*.
Cost: \$40,000 total turn-key project.
Savings: \$100,000+ replacement cost.

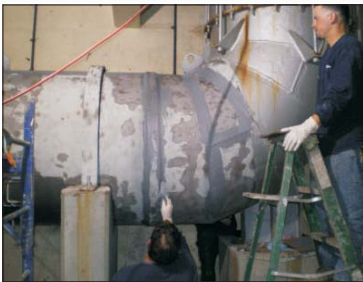
After grit blasting, leaks repaired with DurAlloy.

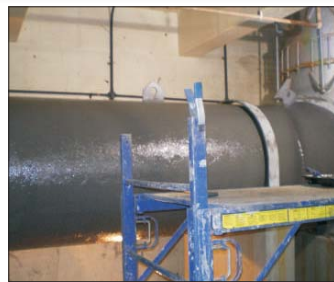
DuraWrap Primer applied.

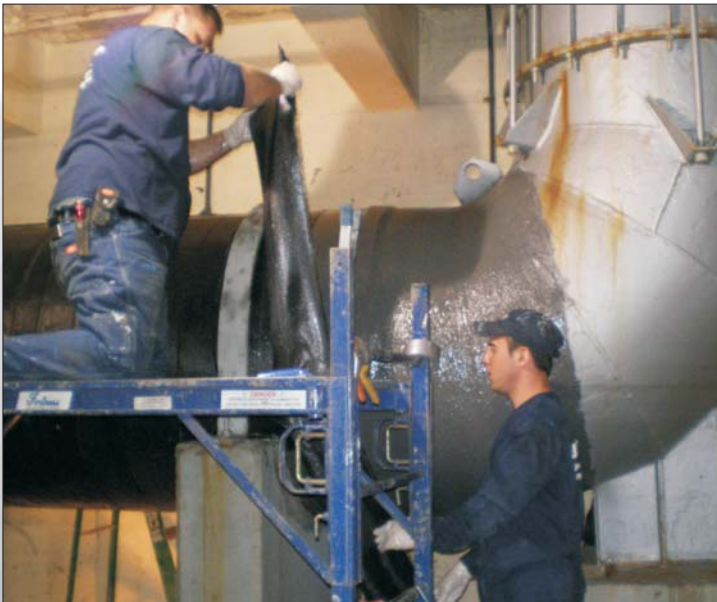
DuraWrap Carbon Fiber, impregnated with DuraWrap Polymers, being wrapped around pipe section.

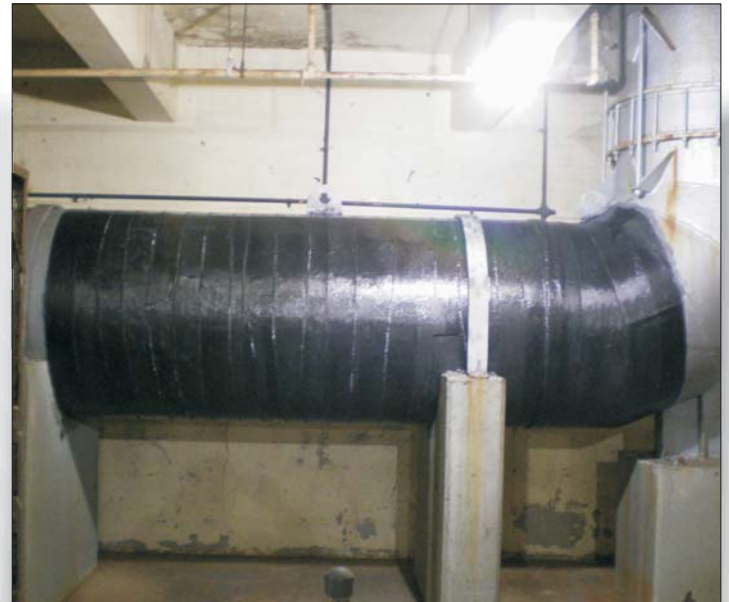
Completed DuraWrap System.
