Municipal Pool Selects DuraQuartz Lightweight & ENESEAL HR For Overhead Concrete Repairs

Location: Municipal pool located in eastern U.S.

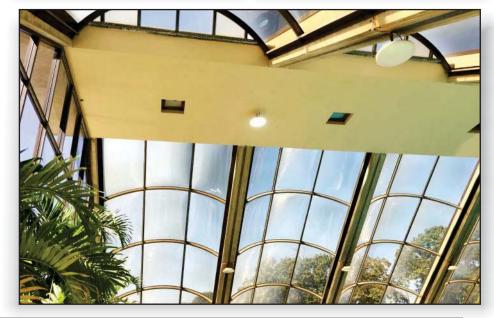
Problem: After years of leaking windows & skylights, the overhead concrete ceiling of this indoor pool building began to crack and spall. The potential for concrete chunks to fall into the pool while it was in use was a serious safety concern of the pool maintenance team.

Solution: The pool was first protected with tarps. Under the tarps were pieces of foam to prevent the tarps from sinking during the concrete preparation.

The concrete was prepared by manually chipping away any loose concrete near the cracks. The prepared areas were then primed and DuraQuartz LW was used to make the repairs. After the repairs were made two coats of ENESEAL HR were then applied.
