Hydroelectric Power Plant Repairs Discharge Ring Cavitation With ENECON DuraTough DL

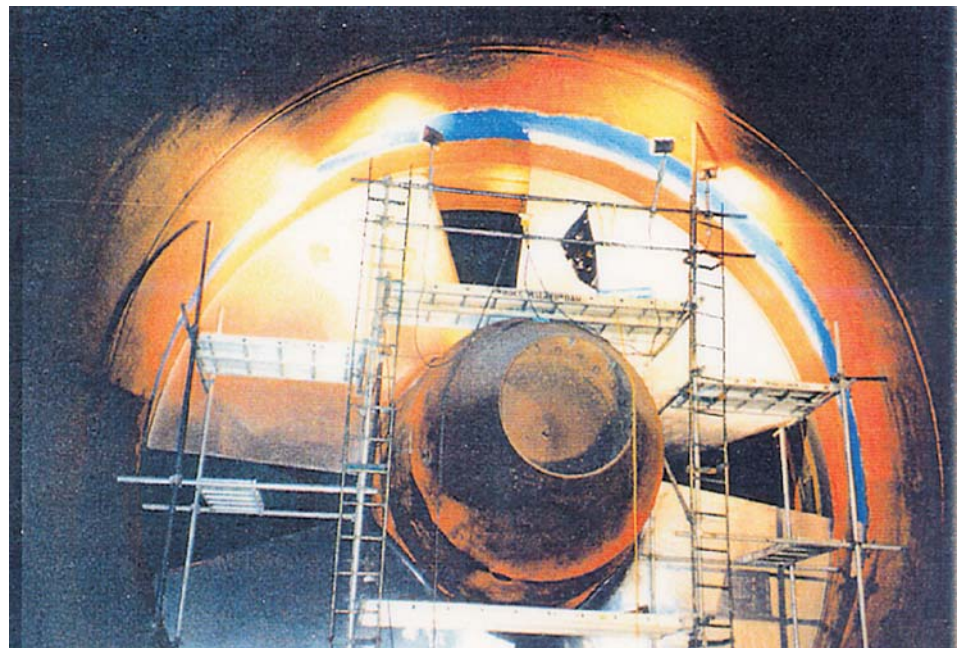
At this hydroelectric generating station, the 25 foot diameter discharge ring needed rebuilding due to cavitation damage. The “band” of damage ranged from about 24 inches in width at the top - where the deepest damage was found - and tapered down to about 12 inches at the 4 o'clock and 8 o'clock positions.

The discharge liner was thoroughly grit blasted and the deeply damaged areas were first rebuilt with METALCLAD DurAlloy to bring the ring surfaces back to the desired original contour. The entire area was then coated with DuraTough Primer and left

to sit overnight before proceeding. The following morning, the first coat of the DuraTough DL - Green was applied, followed by the application of the second coat of DuraTough DL - this time in the Blue color - to complete the application.
