Office Building Drain Pipe Repaired With DurAlloy & Protected With CeramAlloy

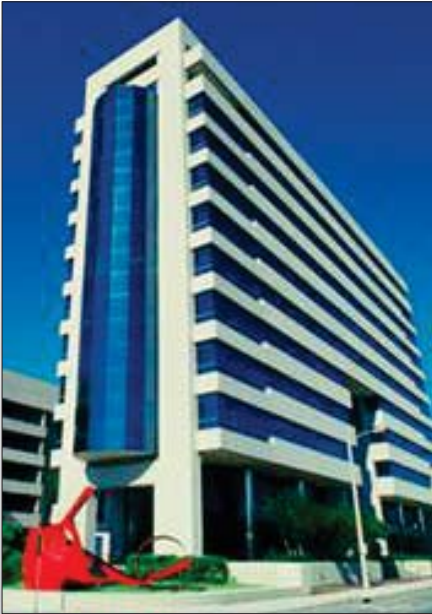
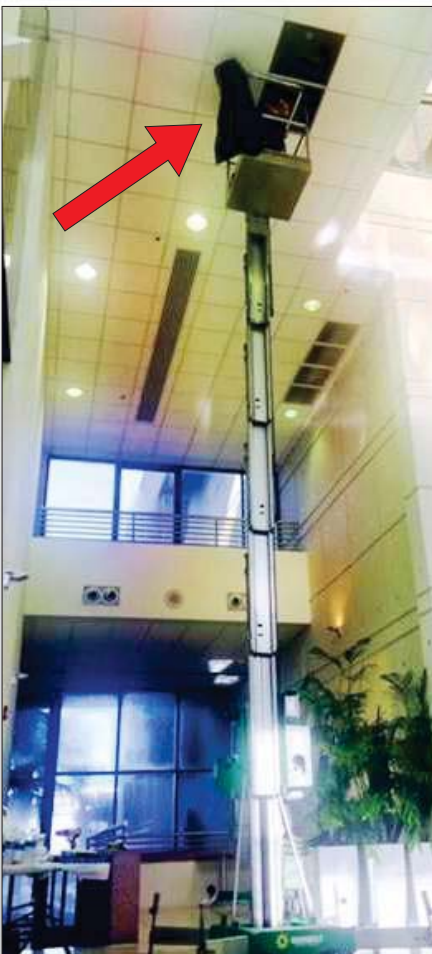
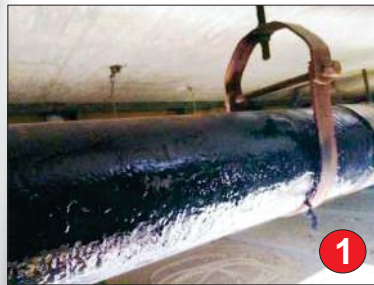
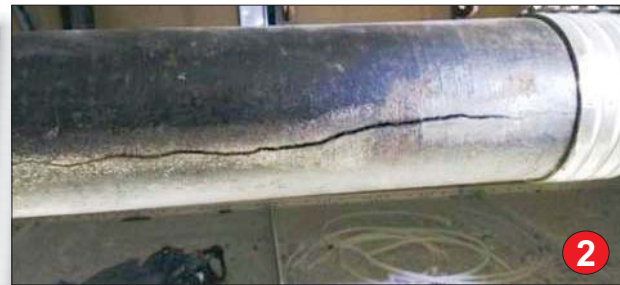
This eight inch diameter drain pipe was located thirty six feet in the air, behind a drop ceiling, in an office building lobby in southern Florida. The building's maintenance team found a three foot long crack in the pipe that was leaking.

Initially, the building's maintenance team used an aerosol spray-on flexible "rubber" repair material which quickly failed. A reliable, proven solution was needed fast. The ENECON Field Engineering Specialist was contacted and a new, trusted solutions was agreed to.

The flexible repair material and rust had to be removed from the pipe. The pipe was

mechanically ground to the appropriate profile. Then the crack was cleaned by using a small wire brush. The pipe was cleaned with denatured alcohol.

METALCLAD DurAlloy was used to repair the cracked pipe surface. Additional DurAlloy was then applied to the entire pipe followed by overlapping layers of reinforcing mesh to provide structural stability to the pipe. A third layer of DurAlloy was applied on top of the mesh.

Finally, METALCLAD CeramAlloy CL+AC gray was applied to the entire pipe to provide ultimate corrosion protection.
