Florida Water Authority Stops Leaking Pump Well Head With DuraFill & Passes State Inspection

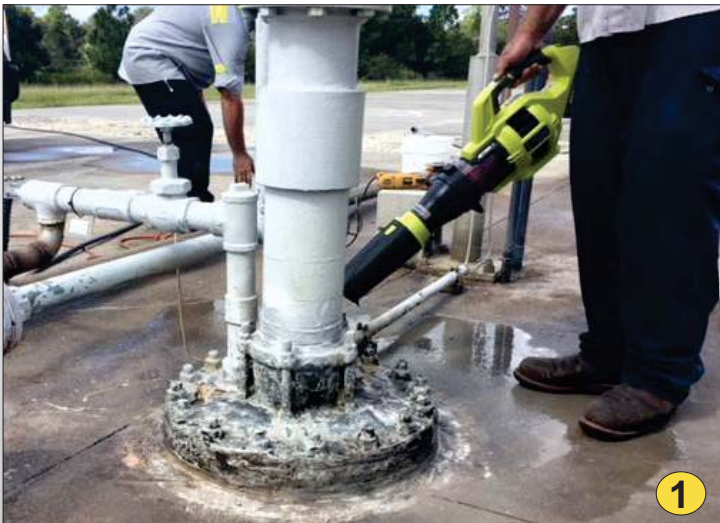
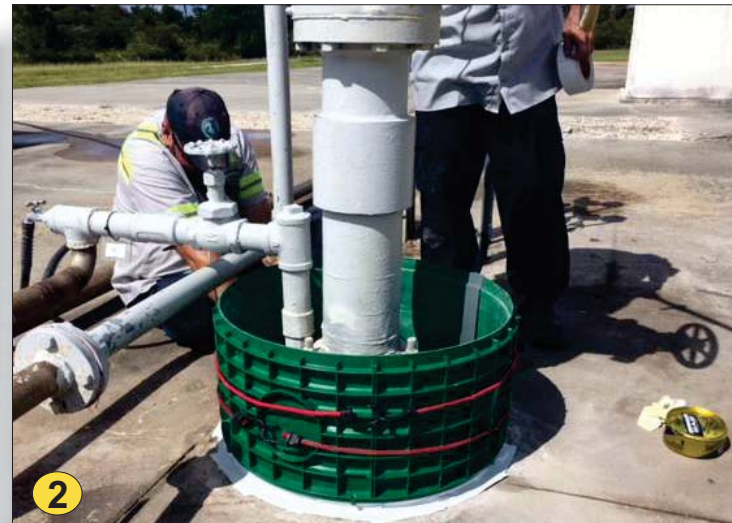
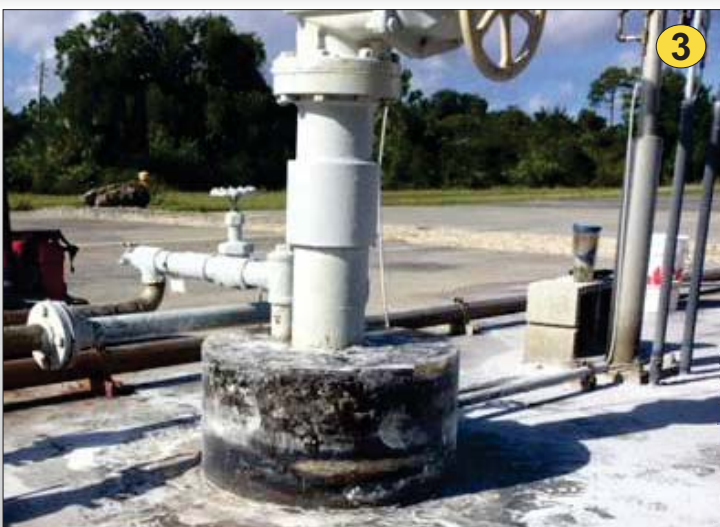
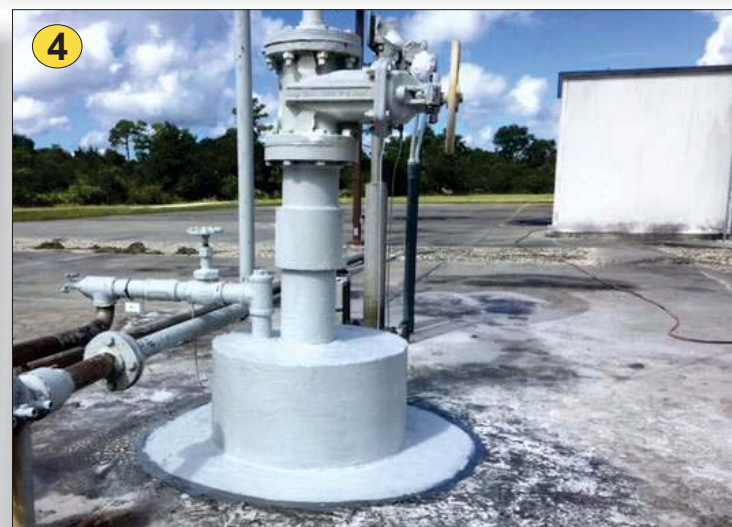
This south Florida water authority needed a repair solution for a broken and leaking pump well head. An upcoming inspection by state officials at the facility, to ensure a mandated zero leakage policy, was taking place in

one week. A replacement head would take 8-10 weeks and cost over \$60,000. If a repair solution was not found, the water authority would have to shut that part of the plant down and also face potential fines.

The local ENECON Field Engineering Specialist suggested encapsulating the pump head in DuraFill because of its unique adhesion and compressive strengths.

A cylindrical former was made and the area was cleaned. A release agent was used to coat the former and the DuraFill was mixed and poured in. The next day the former

was removed and the entire well head was coated with ENESEAL CR to protect the metal components as well as for aesthetics.

The state inspection took place and the DuraFill repair passed with flying colors. This is one problem the water authority no longer needs to worry about.
