Focus on Flange Faces

After the successful repair to one of the two main condensers on the USS Austin (LPD-4) in Gibraltar, one of its sister ships - there are a total of 11 vessels in the Class - the USS Shreveport (LPD-12), was experiencing similar problems while stationed in Norfolk, Virginia.

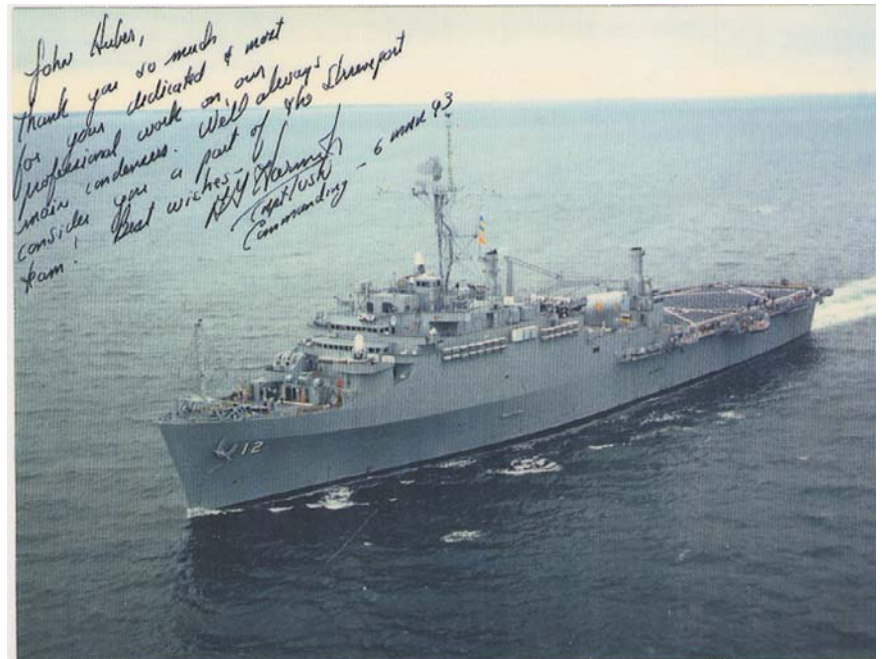
In this case, since there was more time available to carry out the repairs, both condensers were done with the ENECON CeramAlloy. The repairs were carried out using procedures "fine tuned" during the job on the Austin, including the rebuilding of the badly corroded flange faces of the water boxes.

After pulling the boxes, the damaged areas of the flange faces were thoroughly roughened using grinders to cut a coarse "hash marked" pattern in the surfaces.

Release Agent was used on the former to rebuild the corroded faces back to the proper shape.

After mixing the CeramAlloy CP+ and applying it to both the

roughened flange face and to the inside of the former, the former was positioned over the flange surface.

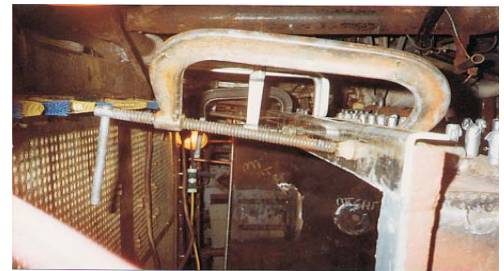
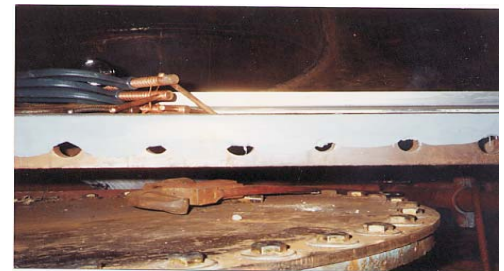
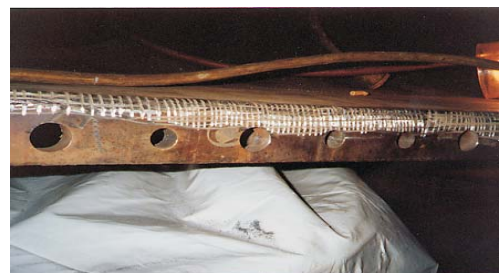
Smooth, ¼ inch thick aluminum angle

Using clamps to draw the former in and squeeze out the excess material, the flange face was rebuilt to the required size, shape and contour, thereby ensuring that the proper seal between the water box and the mating surface on the tube sheet could be achieved without the need for traditional, costly welding and machining procedures.
