## Oregon Paper Mill Repairs Damaged Chipper Disk With CeramAlloy... Savings Could Top \$100,000!

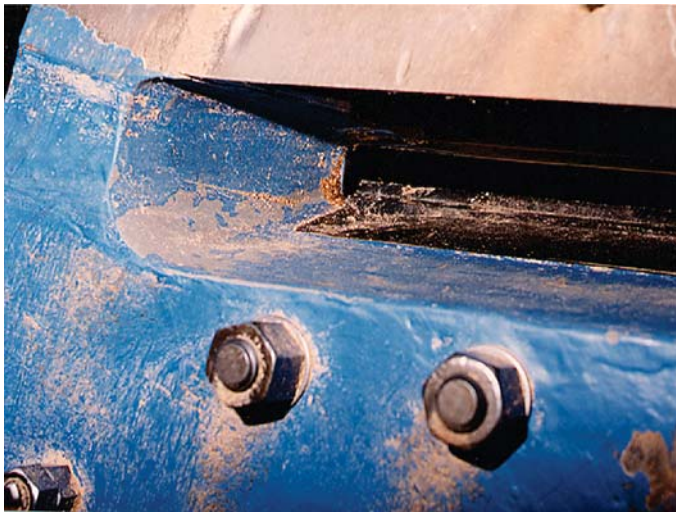
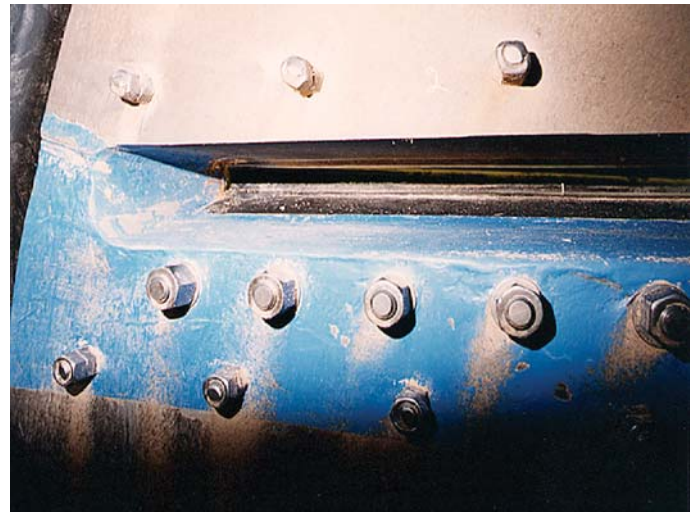
One year after repairs were made to all 8 pockets of a large (150+ inch diameter) chipper anvil, the enclosed photos were taken. The repairs involved rebuilding badly worn areas, which, if allowed to progress, would have threatened the structural integrity of the wheel. Replacement would have cost up to \$100,000 plus even more costly downtime

pocket had been eroded by about 2 inches, the shelf by  $\frac{3}{4}$  inch, and the face by up to  $\frac{1}{2}$  inch. Two kilograms of CeramAlloy CP+ were used to rebuild each pocket, followed by an overlay of CeramAlloy CL+ to protect the first eight inches of the face. Material costs were less than \$3,500, and labor consisted of two plant people, plus the ENECON Field Engineer, for 1-

In the pictures, wood residue shows as discoloration, especially on the face. The CL+ in those areas is virtually unaffected. The knives are changed daily by loosening the top two rows of studs with an impact wrench. The wrench has chipped pieces out of the face, but these do not progress beyond

the initial damage, and are not considered significant. Incidentally, the erosion is so severe that the steel nuts are worn round and must be replaced frequently!
