## U.S. Navy Salvages Main Salt Water Circulating Pump on an Amphibious Assault Ship with CeramAlloy

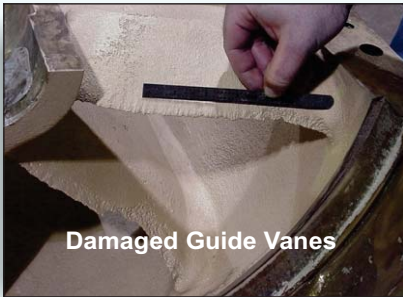
Damaged Guide Vanes

ENECON Hampton Road's Pier Side Rapid Availability Team (P.R.A.T) were recently called in to solve a severe erosion/corrosion issue on the main sea water circulating pump that feeds the main steam condenser on an LHD vessel. This class of ships carries helicopters, Harriers (vertical take-off jets), LCAC's (Landing Craft - Air Cushion hover crafts) as well as about 2,000 Marines and all their equipment. It is a key component of the U.S. Navy's amphibious assault arsenal.
