## DuraWrap Saves Main Influent Pipe at Waste Water Treatment Plant

- Location:** Northeastern U.S.  
**Problem:** Corroded & leaking main influent pipe.  
**Solution:** Repair leaks with *DurAlloy*; reclaim pipe with *DuraWrap Carbon Fiber Pipe Wrap System*.  
**Cost:** \$40,000 total turn-key project.  
**Savings:** \$100,000+ replacement cost.

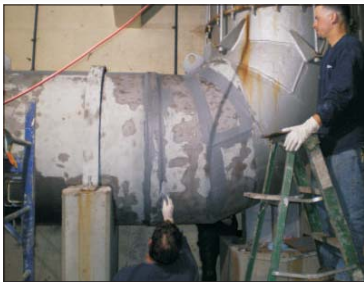
After grit blasting, leaks repaired with DurAlloy.

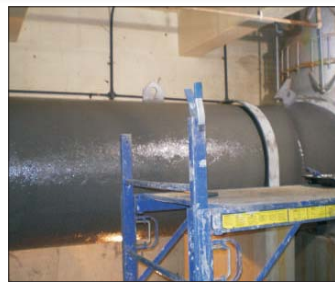
DuraWrap Primer applied.

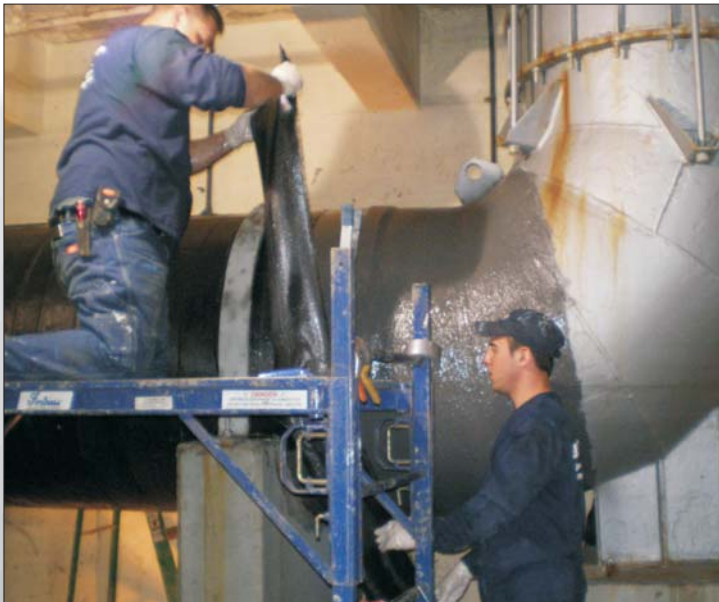
DuraWrap Carbon Fiber, impregnated with DuraWrap Polymers, being wrapped around pipe section.

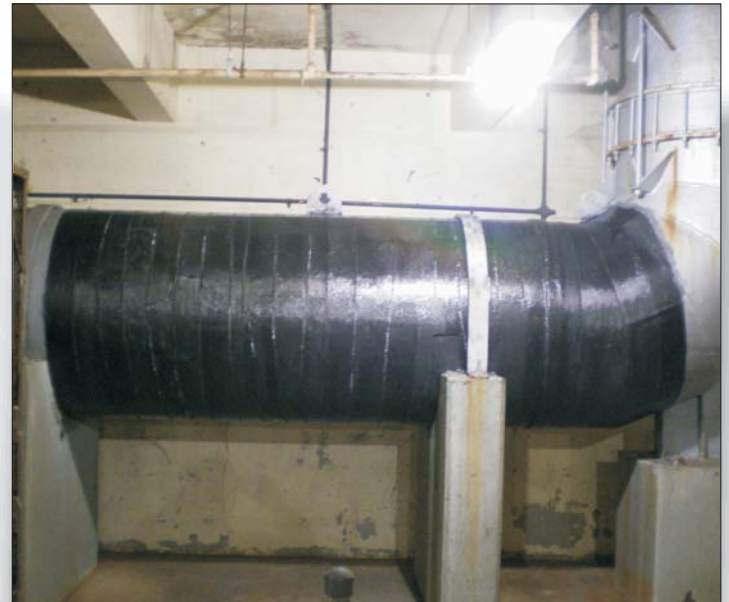
Completed DuraWrap System.
