Oil Company in Thailand Repairs 22 'Problem Areas' with DuraWrap

Client: Major oil company

Location: Thailand

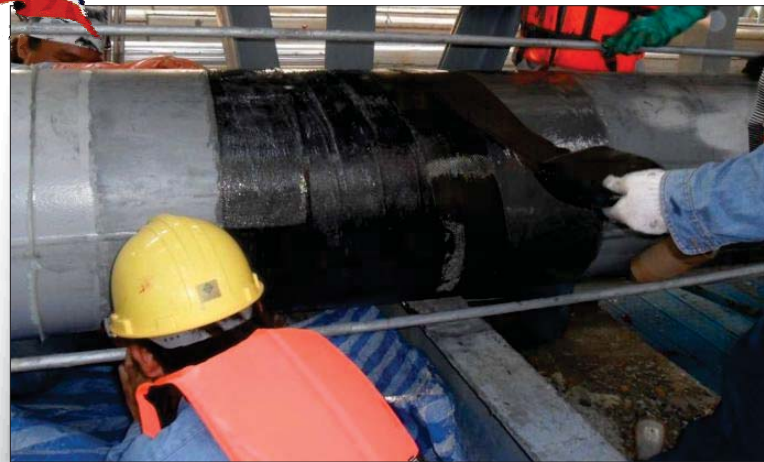
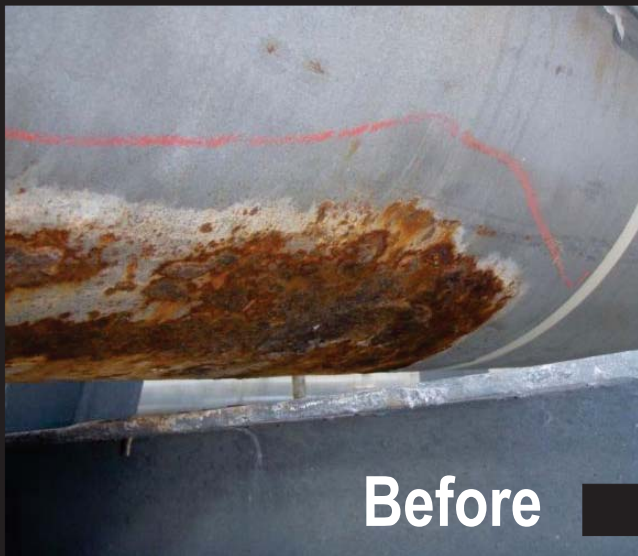
Before

Problem: 20" diameter pipe was severely rusting in 22 different locations.

Solution: Original galvanized coating was removed. Rusted areas were manually prepared by grinding and wire brushing. *DurAlloy* was used to repair any damaged areas on the pipe. *DuraWrap Primer* was applied followed by two layers of *DuraWrap Carbon Fiber System*.
