Romanian Wastewater Treatment Facility Repairs Impeller Shaft with DurAlloy

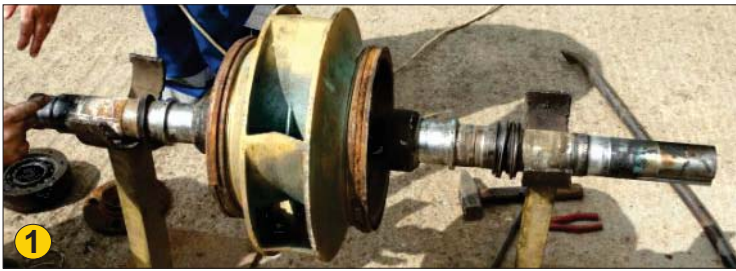
1. Impeller shaft in bad condition after years in service needs to be repaired.

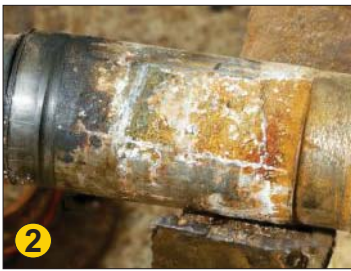
2. Corrosion and wear to the shaft rendered it unusable.
