Cooling Tower Pipes Are Salvaged With METALCLAD & ENESEAL

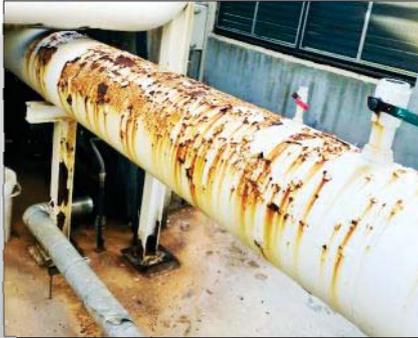
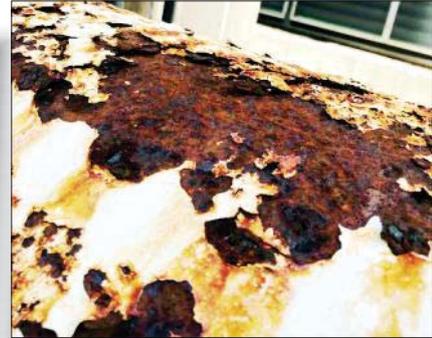
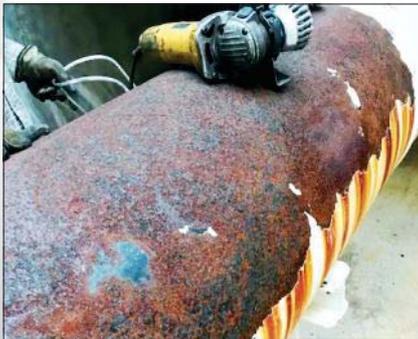
These cooling tower pipes at one of the largest hospitals in northern Louisiana were in a very corroded state. The hospital was considering replacing these pipes at an estimated cost of \$85,000, with considerable downtime. The downtime was the most troublesome issue for the hospital; they needed a solution that would allow them to keep the units operating.

Over the last few years, the hospital had continually painted the pipes, encapsulating the rusting areas unknowingly giving the rust a 'safe' place to live and thrive. After inspection, several sections of the pipes had considerable metal loss and there were also active leaks.

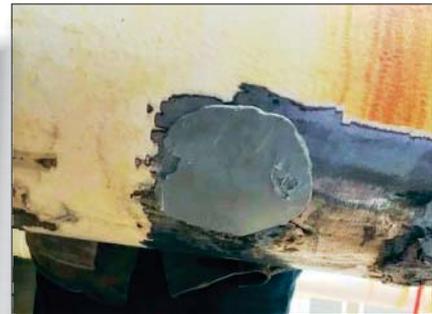
SpeedAlloy QS stops the leaks.

First, SpeedAlloy QS was used to stop all of the active leaks. After all the leaks were sealed, DurAlloy

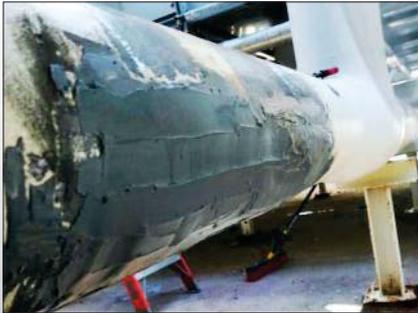
Repairs made with DurAlloy.

was then used to repair the areas with major metal loss. DuraWrap Carbon Fiber Pipe Wrap was used to reinforce the areas where the leaks were sealed and the metal loss repaired.

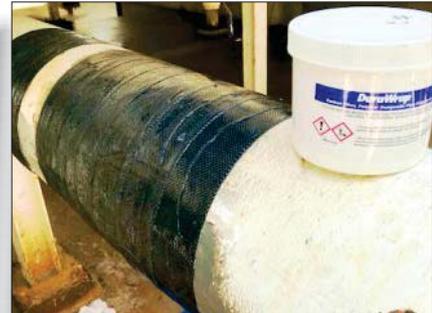
Reinforcing with DuraWrap.

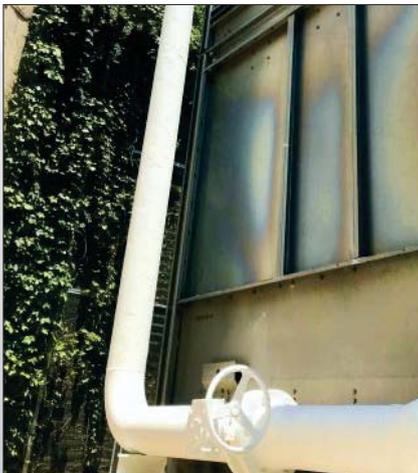
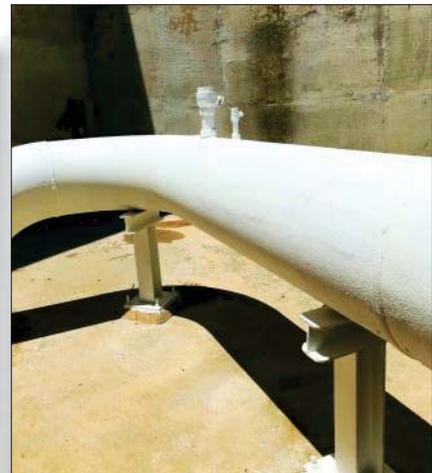
Two coats of ENESEAL CR.

Finally, two coats of ENESEAL CR were applied to all of the pipes, as well as their structural legs and concrete bases, to provide corrosion resistance. All of this work was performed with absolutely no interruption the hospitals operations.
