DuraWrap Saves Main Influent Pipe at Waste Water Treatment Plant

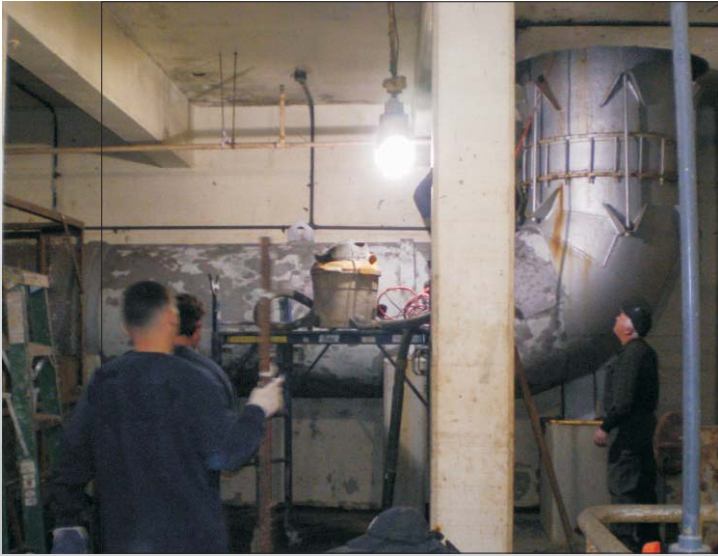
- Location:** Northeastern U.S.
- Problem:** Corroded & leaking main influent pipe.
- Solution:** Repair leaks with *DurAlloy*; reclaim pipe with *DuraWrap Carbon Fiber Pipe Wrap System*.
- Cost:** \$40,000 total turn-key project.
- Savings:** \$100,000+ replacement cost.

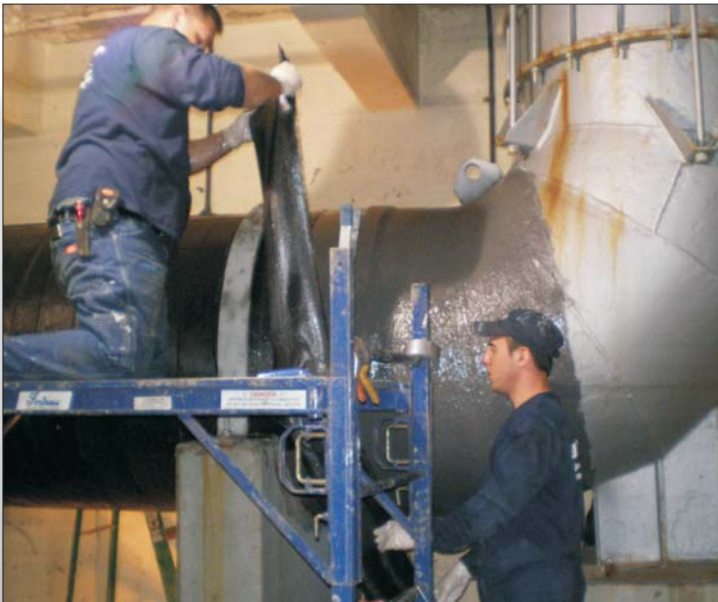
DuraWrap Carbon Fiber, impregnated with DuraWrap Polymers, being wrapped around pipe section.

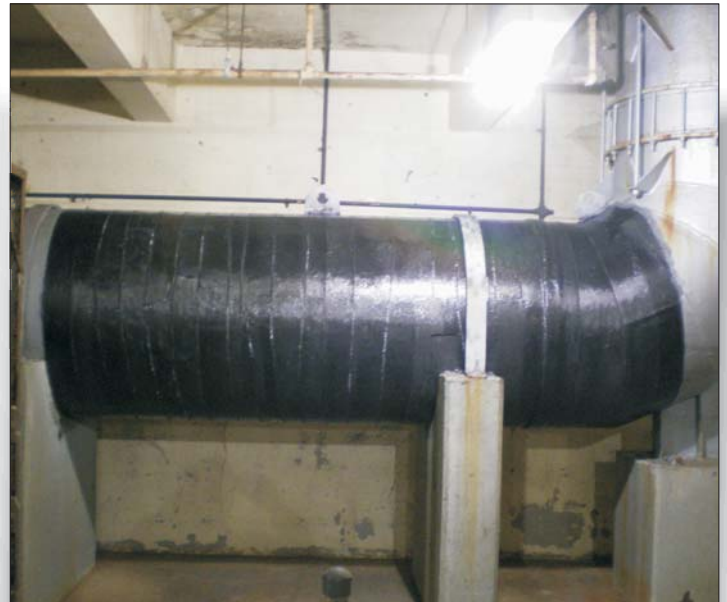
Completed DuraWrap System.
