Skyscraper Cooling Tower Corrosion Problems...No Match for CHEMCLAD!

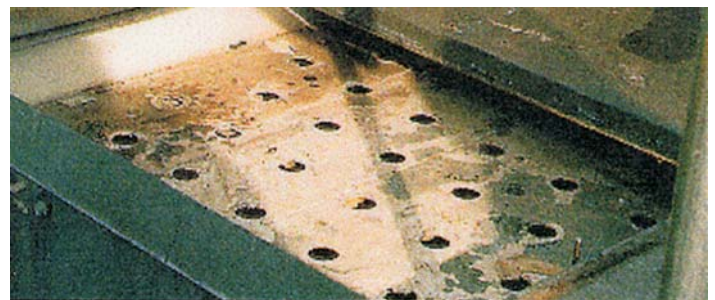
The most recent attempt at solving the corrosion problem was to coat the units with a pool paint in order to protect the galvanized metal pans. The coating lasted only a few months and then began to peel -- creating even more

Pool paint peeling on pans poses problems.

Due to the cold weather, the entire area had to be covered with tarpaulins and heated. Then the ENECON Team, hoisted compressors, blasting equipment and supplies to the roof -- some 60 stories high -- and completed this \$10,000 project in just a few days.

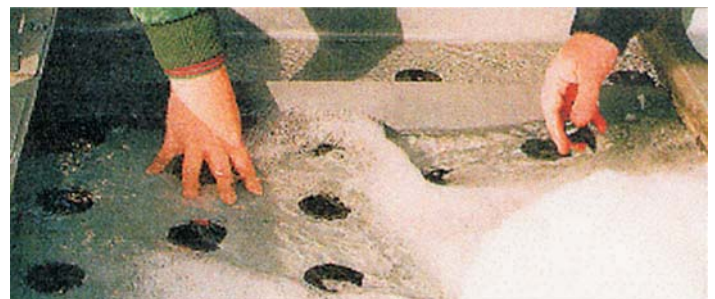
Problems solved & pans protected with CHEMCLAD SC.

solution...CHEMCLAD SC.
