This large paper mill in Italy processes huge rolls of white paper stock to make cigarette boxes for one of the largest tobacco producers in the USA.

The specialized ROTOMECH equipment - which bonds aluminum foil to the cardboard and imprints the outside of the boxes with a special red color - takes up an area of some 1,400 square feet (130 square meters) of the facility.

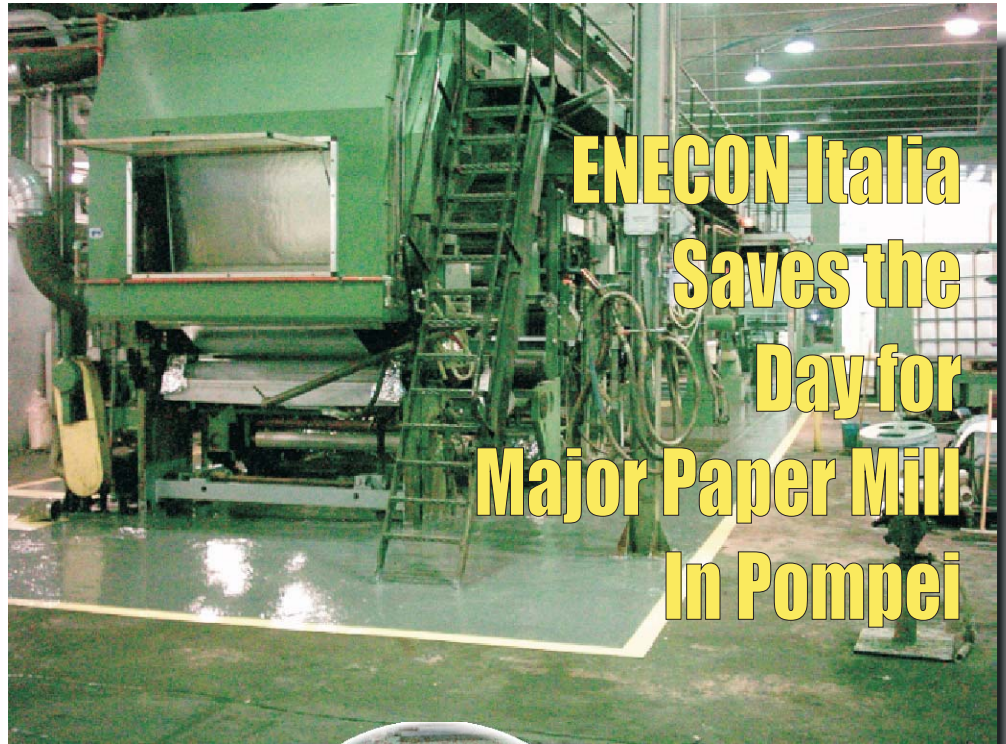
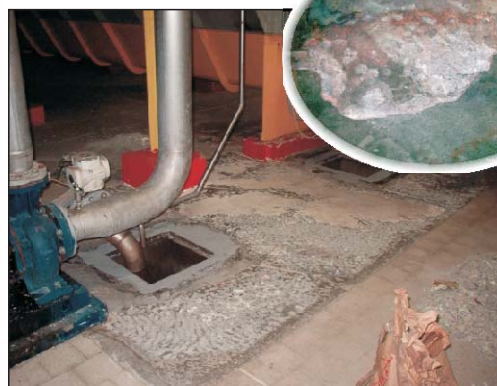
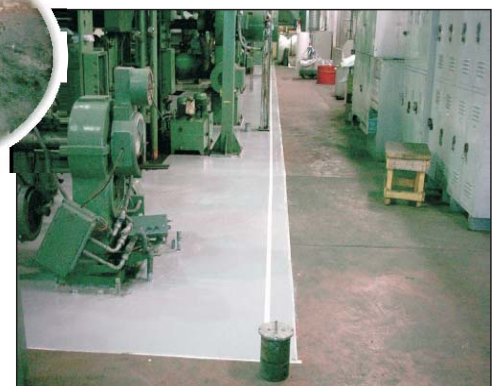
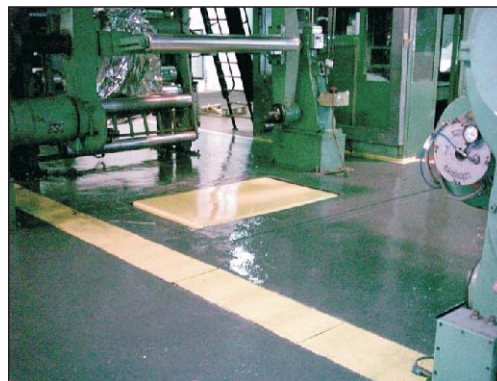
The ink used to color the cartons had damaged the concrete so extensively that the cigarette company representatives ordered the production line stopped until an acceptable repair could be carried out.

ENECON Italia was called in to provide a solution to the problem. All damaged concrete was removed and repaired with ENECRETE DuraQuartz. The entire area was then treated with CHEMCLAD P4C followed by two coats of the CHEMCLAD SC.

With an ENECON specialist on hand for support, the entire project took two men a week to complete. The cigarette company representatives were so impressed with the ENECON solution that they immediately lifted the "Stop Work Order" and the equipment was immediately put back into service.
