CHEMCLAD XC “Cures” Shower Stall Problems at New Jersey Hospital

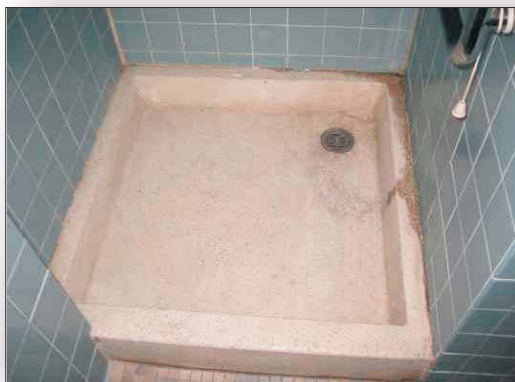
Worn, pitted basins were unsightly & impossible to clean.

After years of constant use, the basins had become worn and pitted and the original sealer finish was gone. The basins were nearly impossible to clean and unsightly as well. Patients were reluctant to use the showers. Since occupancy is as important to a hospital as to a hotel, each shower had to be completed in one day as rooms became available.

The solution was the application of CHEMCLAD XC, tinted to the color (blue) selected by the hospital staff to compliment the wall tile color.

After acid washing the basins to remove imbedded soil, soap residue and rust stains, the basins were dried using a fan.

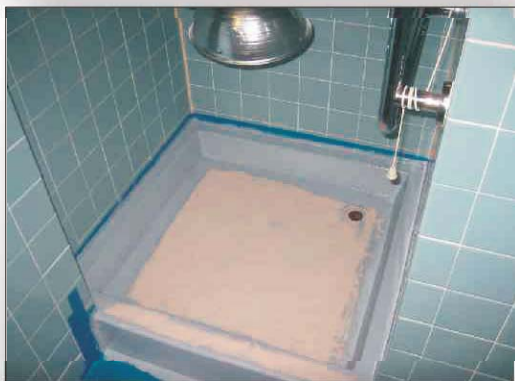
Heat lamps were used to accelerate the cure of the first layer of CHEMCLAD XC

A first layer of CHEMCLAD XC was applied by brush and roller. An anti-slip aggregate was broadcast into the uncured CHEMCLAD XC. This filled in pits in the concrete surface and improved the safety of the showers. After sweeping up the excess aggregate, a second layer of CHEMCLAD XC in the finished color was applied.

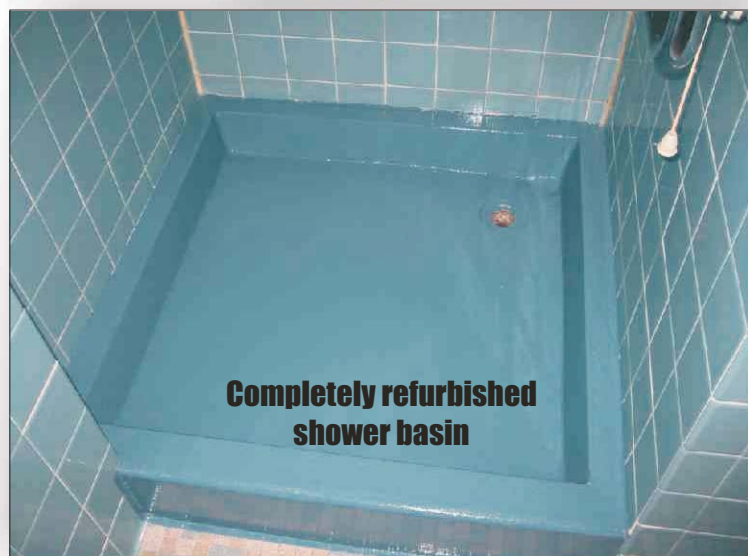
The finished basins have an easy-to-clean and safe “diving board” finish. Over 80 showers have received this treatment.
