Biotech Company Solves Chemical Problem in Their Research Lab with SuperBond and CHEMCLAD XC

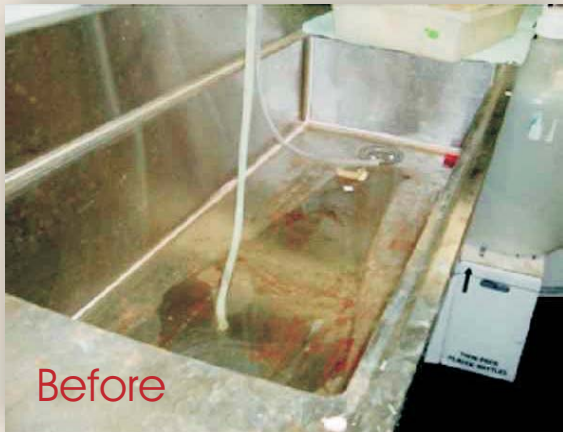
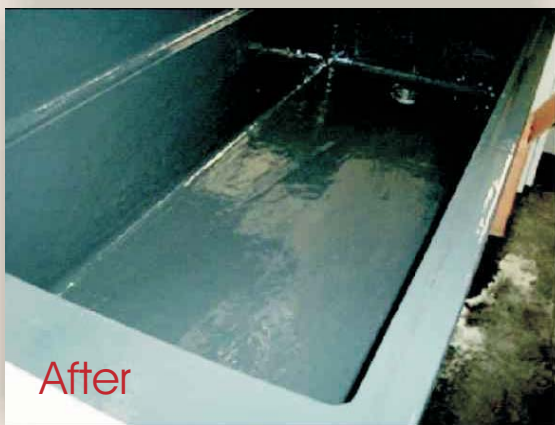
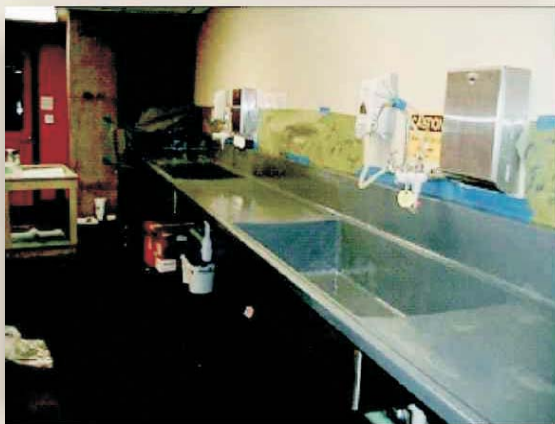
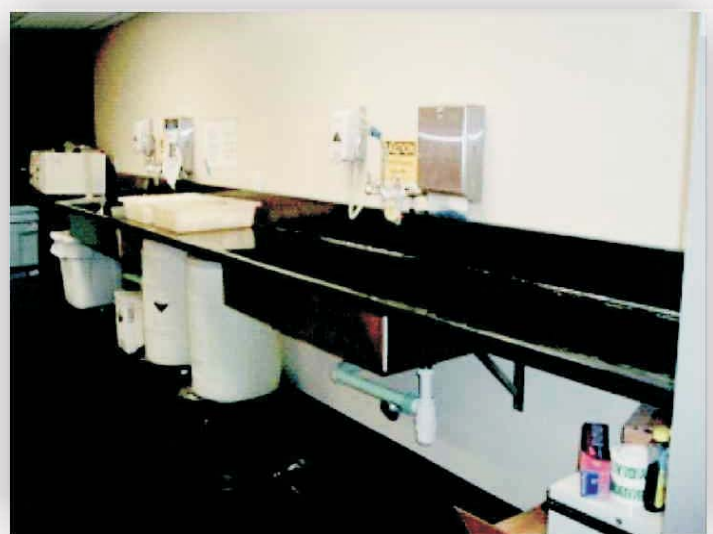
A prestigious biotech company, based in Seattle, WA, was experiencing a serious corrosion problem on their stainless steel sinks in one of their research laboratories. They needed a quick and environmentally friendly answer. Their SOS went out to the ENECON Northwest Engineering Team, who proposed a very cost effective repair solution.

Since grit blasting was out of the question in the lab, Allen Thomas, ENECON's District Sales Manager in Seattle, proposed a thorough cleaning of the

stainless steel surfaces and a final wipe with acetone. ENECLAD SuperBond was applied to all stainless steel surfaces and then two coats of CHEMCLAD XC were applied to seal any pinholes and protect the sink surfaces from future chemical attack.

The application was completed in just two days with minimal disruption to the research laboratory personnel.
