CHEMCLAD SC & DurAlloy Solve Corrosion Problems at Indonesian Plant

The local ENECON Dealer located in North Sumatera Island in Indonesia was asked to provide a commercially proven, cost effective solution for this condenser pump repair and protection project at a state owned power station.

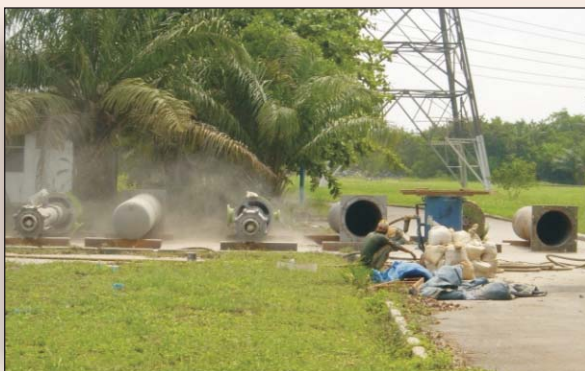
All pump sections were grit blasted.

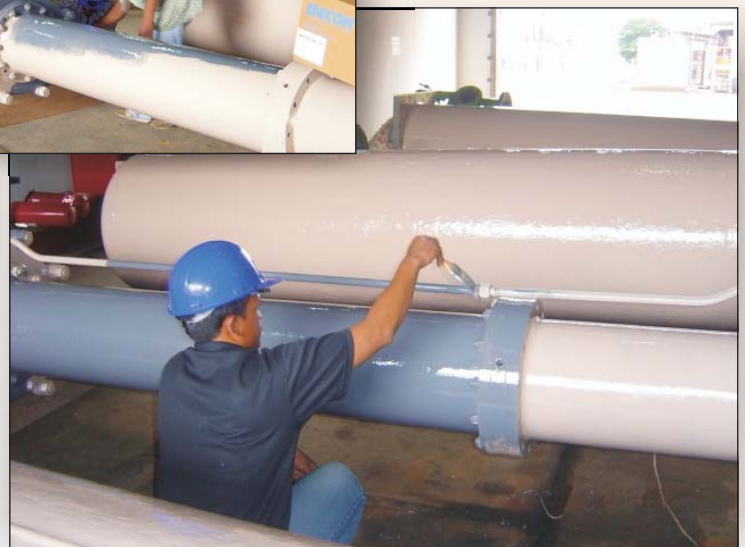
Final coat of CHEMCLAD SC being applied.
