## CHEMCLAD SC & DurAlloy Solve Corrosion Problems at Indonesian Plant

The local ENECON Dealer located in North Sumatera Island in Indonesia was asked to provide a commercially proven, cost effective solution for this condenser pump repair and protection project at a state owned power station.

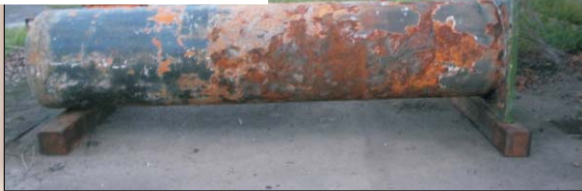
*Note the blistering & under-film corrosion of the conventional epoxy paint system*

The existing epoxy coating had failed badly and under-film corrosion was destroying the spool

The repair procedure included thorough grit blasting of the metal. All deeply pitted and damaged areas were then re-built with METALCLAD DurAlloy and sanded smooth.

Two coats of CHEMCLAD SC were then applied to provide long-term protection to these pump sections.

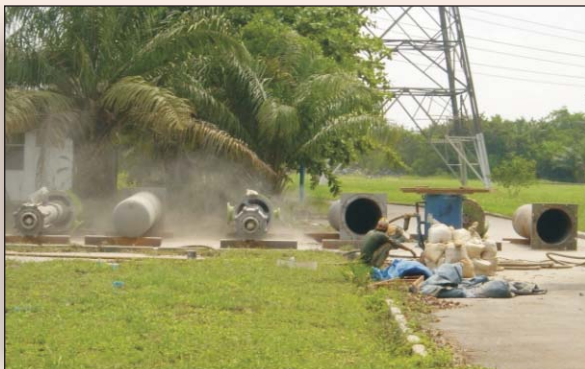
All pump sections were grit blasted.

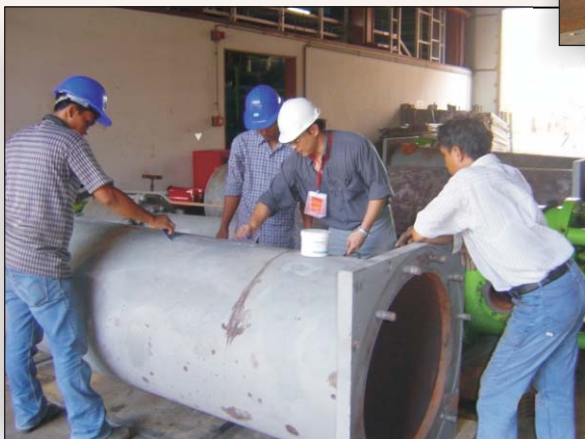
DurAlloy being applied to repair pitted areas.
