CHEMCLAD XC Solves On-Going Corrosion Problems in Sulfuric Acid Loading Area at Australian Nickel Mine

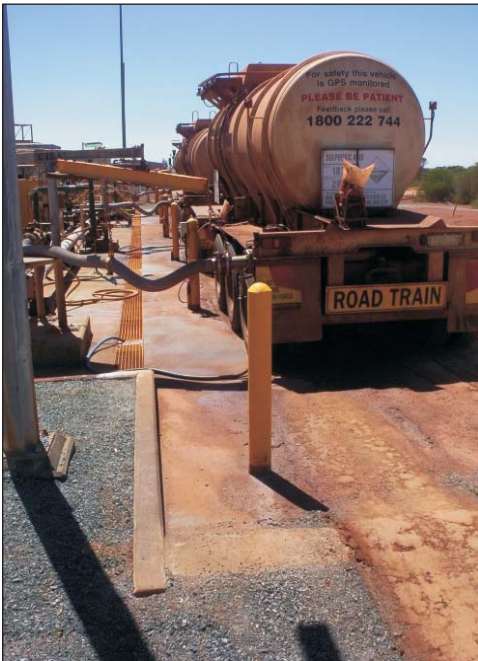
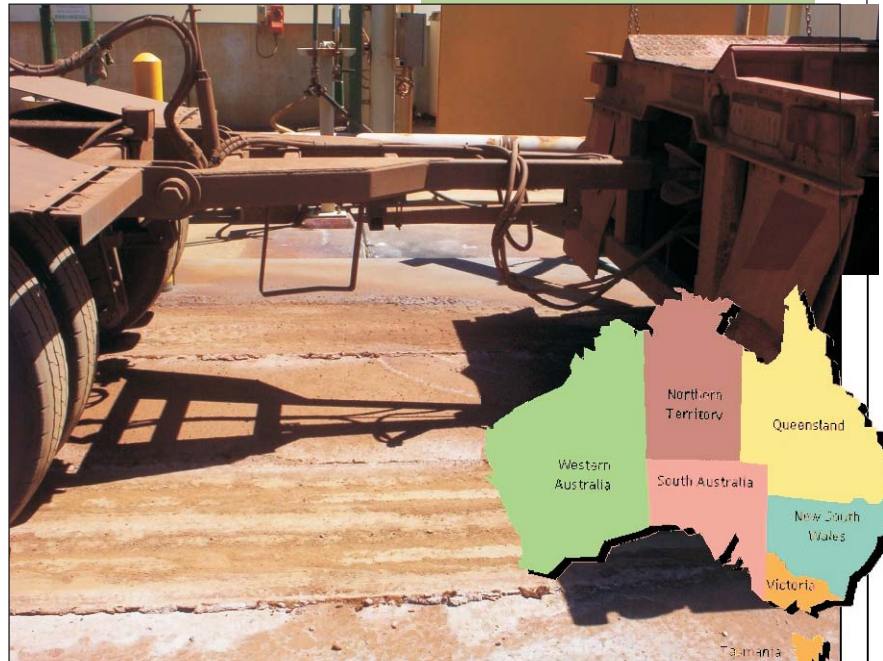
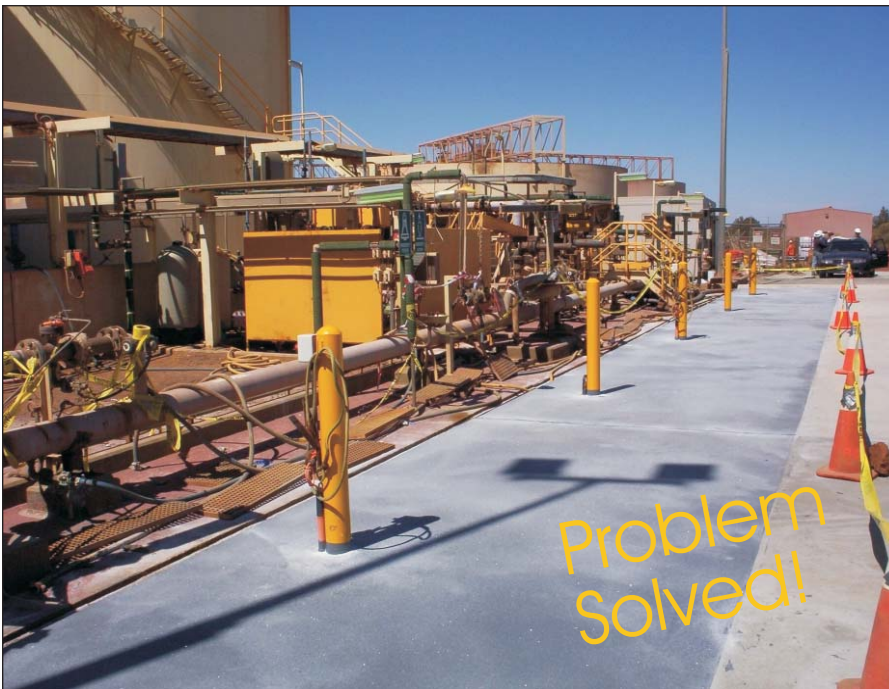
The maintenance engineers at this Laterite Nickel Mine in Western Australia had a very severe corrosion problem in this concrete loading bay. Trucks load and unload chemicals in this area 7 days a week.

Various high-build coatings and patching materials were tried over the years with very poor results. The engineers turned to the ENECON Australia Industrial Solutions Team for help. They recommended CHEMCLAD XC, ENECON's finest chemical protection system, be used to completely seal the entire loading bay with outstanding results.
