## Italian Coast Guard Selects CHEMCLAD XC To Solve Corrosion Issues

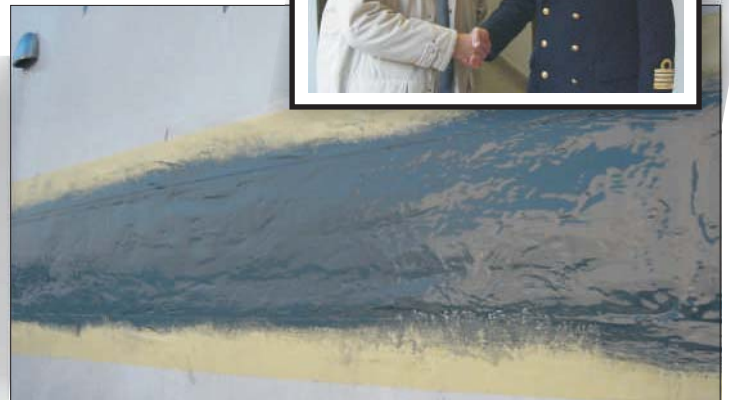
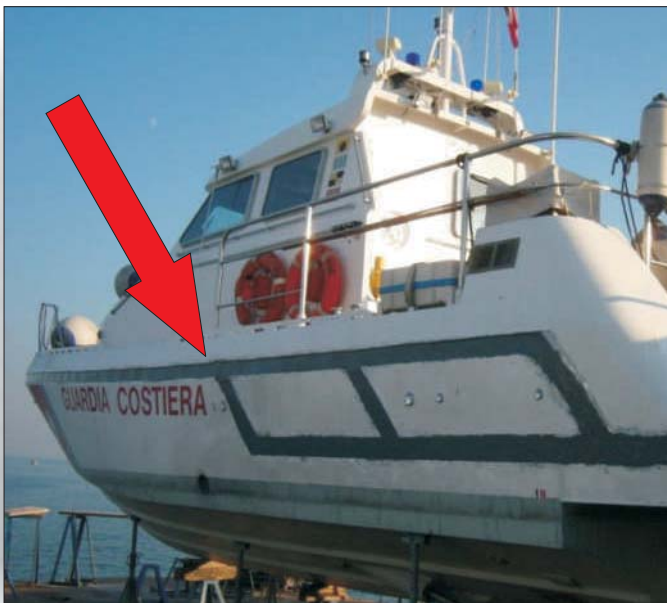
This Italian Coast Guard vessel had been experiencing some severe corrosion on its hull.

The affected area was first grit blasted to remove all corrosion and prior coatings. The entire area was then rebuilt with 6 mm of CeramAlloy CP+AC and reinforcement mesh.

This repaired area was then protected with CHEMCLAD XC.
