CHEMCLAD Stops Corrosion at Chilean Pasta Factory

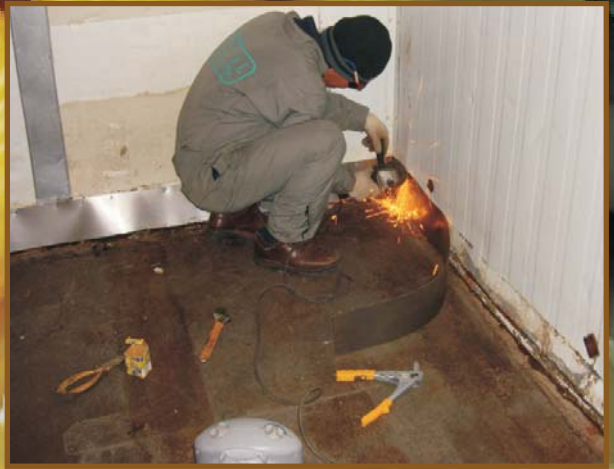
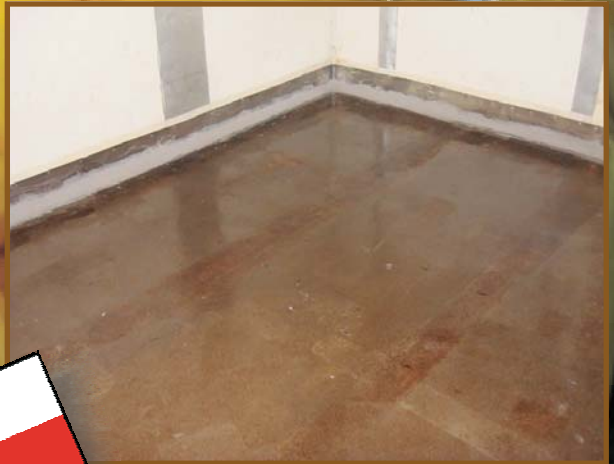
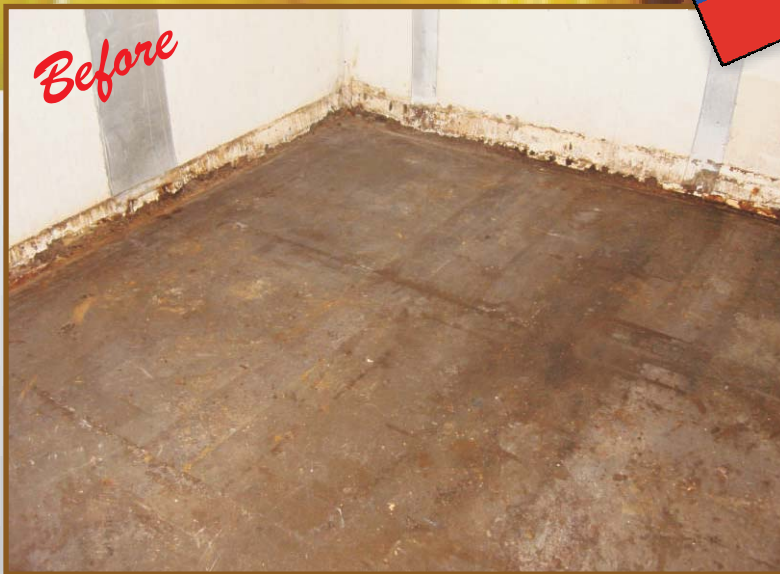
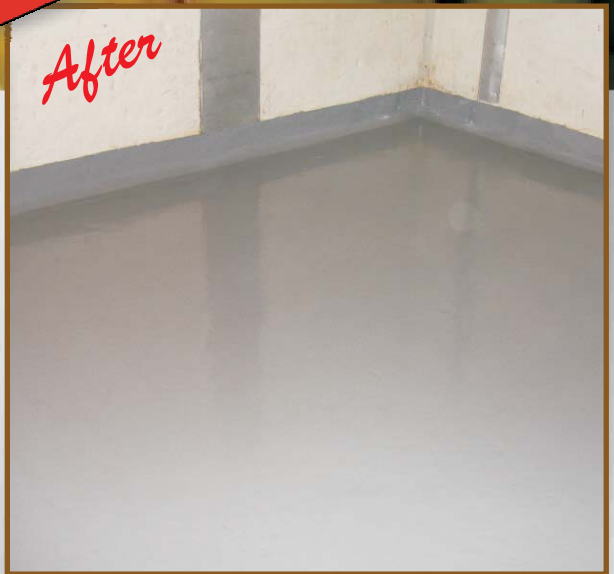
At a major pasta factory located in Chile the floor of this refrigerated egg storage room floor was suffering from corrosion after many years of accidental egg breakage. Since eggs are corrosive in nature, the factory's maintenance team was looking for a fast yet cost effective way to repair and protect this area from future corrosion.

The floor was first thoroughly pressure washed and allowed to dry. A new

metal sheeting baseboard was then installed. **ENECRETE DuraQuartz** was used to radius the transition between the floor and the wall.

ENECLAD Clear Floor Sealer was used to prime the floor surface quickly followed by one coat of **CHEMCLAD SC** with a broadcast of aluminum oxide to provide slip resistance. A final **CHEMCLAD SC** coat was then applied.
