Sweep Arm's "Smooth Ride" Courtesy of ENECRETE DuraQuartz

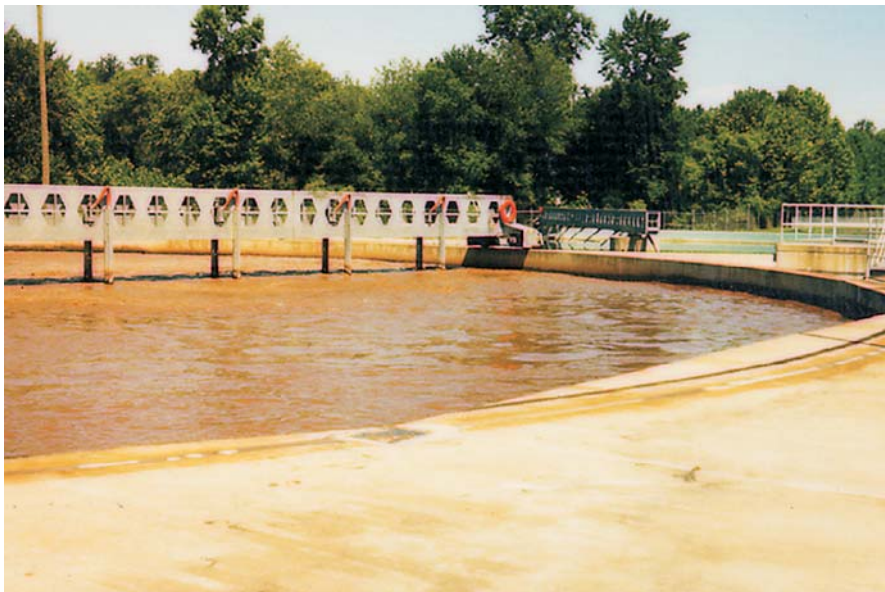
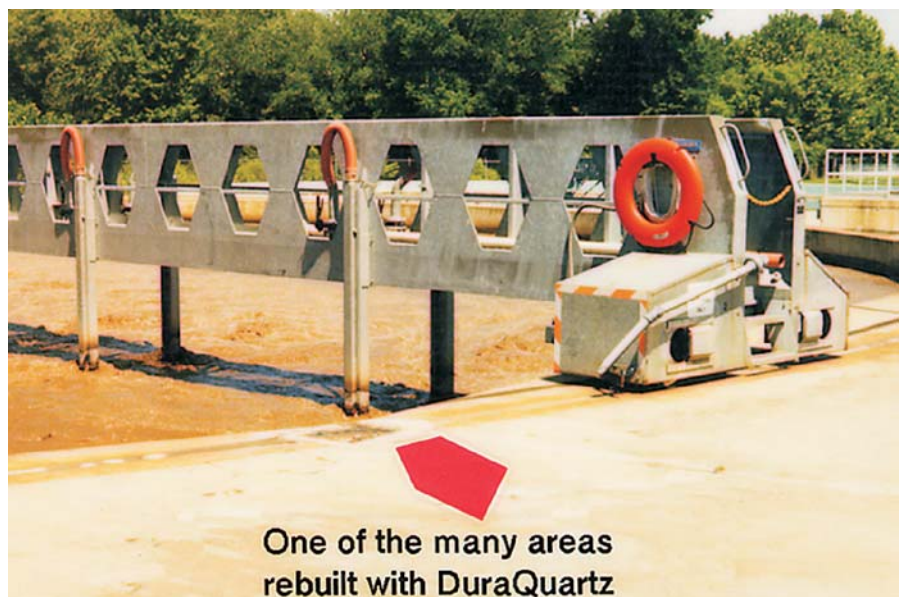
The top of the concrete wall of this 140 foot diameter aeration basin at a **Waste Water Treatment Plant** had numerous cracks and spalled areas. These irregularities in the track area caused the wheels of the "sweep arm" to bounce, further damaging the concrete and stressing the equipment.

The engineers tried numerous repair materials in trying to solve the problem. However, nothing they found could stand up to the 7 ton load carried by the two track wheels as they rotated the basin every two minutes.

The local ENECON Fluid Flow Systems Specialist in Virginia, suggested the use of the ENECRETE DuraQuartz to solve the problem. Impressed with the outstanding properties of the DuraQuartz, the plant's Maintenance Supervisor agreed to give it a try.

The Supervisor reported that, **not only is the DuraQuartz "doing the job", but the smoother riding wheels would extend the life of the sweep arm as well as allow for better air circulation into the aeration basin.**
