DuraQuartz & CHEMCLAD Used to Repair Tile Floor at Pennsylvania Hospital Kitchen

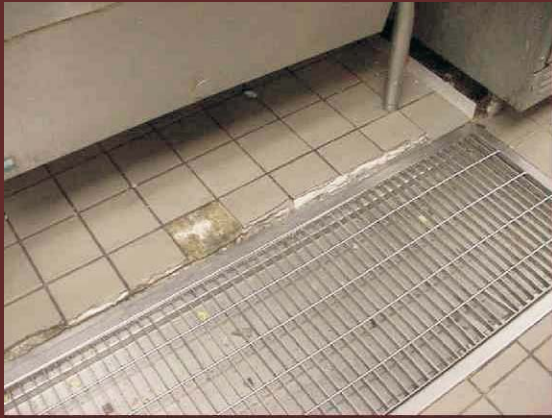
Portions of tiles where grout had failed were chipped away.

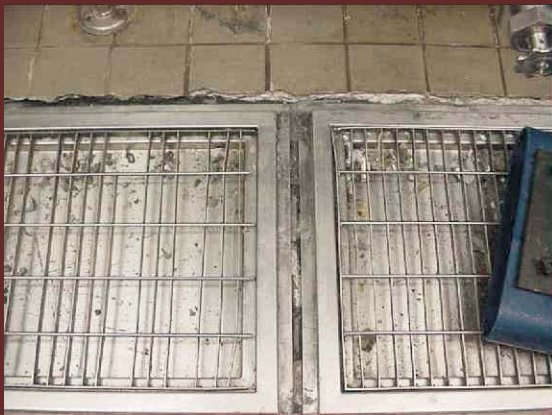
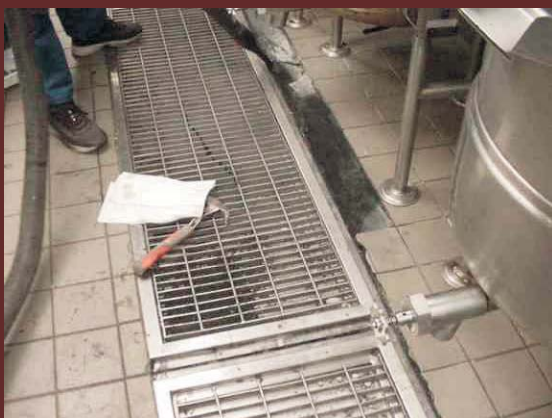
Some tiles were in such poor shape that they were completely removed.
