ENECRETE WP & WS Solve Leaking Elevator Pit Problems for National Hotel Chain

The following story and pictures were supplied by ENECON's District Sales Manager based in San Diego, Camille Segobia. Her report reads as follows:

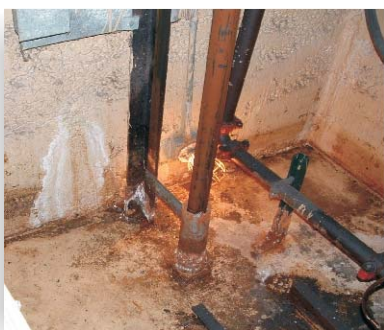
The project became very involved because there was a great deal of oil and a very thick existing coating that had been pushed deeply into

numerous crevices and holes in the concrete. It took 5 workers, 2 days to remove the existing coating using needle guns. The problem was so severe because the elevator pit was not made of cinder block, but instead, it was a poured concrete pit - poured in 3 sections allowing gaps and crevices to form between each pour.

Elevator Pit Before

We used 2 units of ENECRETE WP and 8 units of ENECRETE WS, coating four feet up the pit walls.

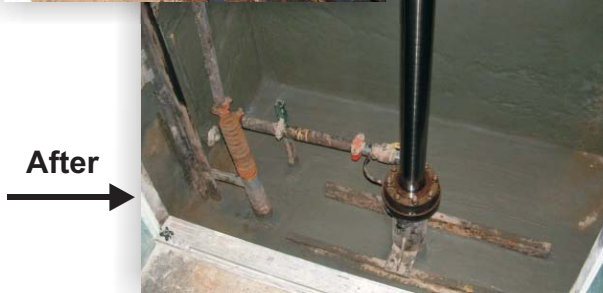
After

The project was completed on time. The client and the State inspector were both very pleased with the results."
