Major Florida Utility Company Solves Recurring Concrete Problems with ENECRETE DuraFill & DuraQuartz

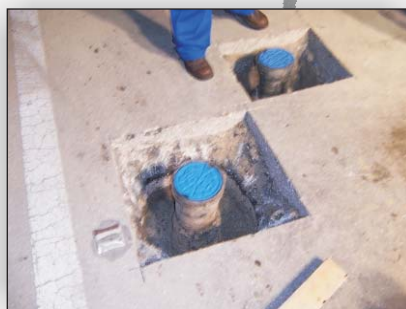
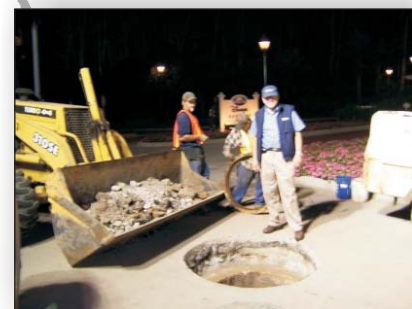
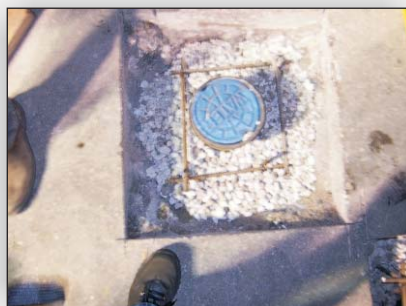
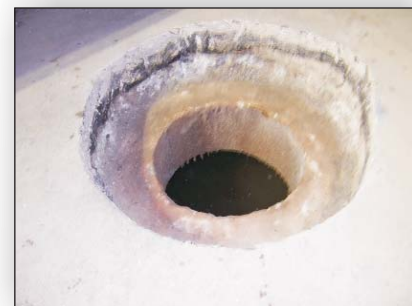
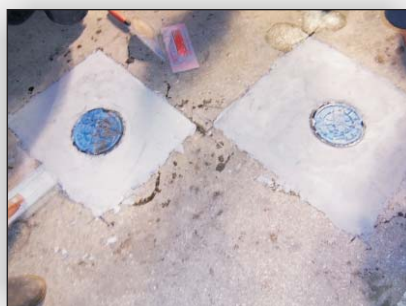
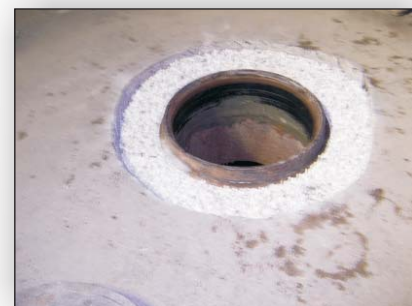
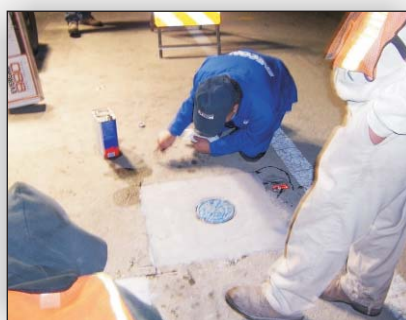
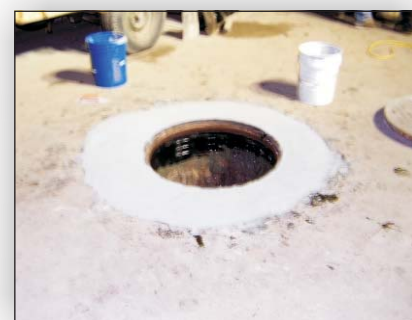
The utility purchased a few skid-loads of these materials in order to complete a number of such repair projects. These pictures illustrate just a few of them.

The Utility Engineers turned to their local ENECON Field Engineering Team who recommended our ENECRETE systems for these applications. **DuraFill** mixed with locally acquired large aggregates was first utilized to fill in the deep holes and then **DuraQuartz** was used to top-off the repair (about ½ thick) to provide for an extraordinarily durable road surface.
