Major Florida Utility Company Solves Recurring Concrete Problems with ENECRETE DuraFill & DuraQuartz

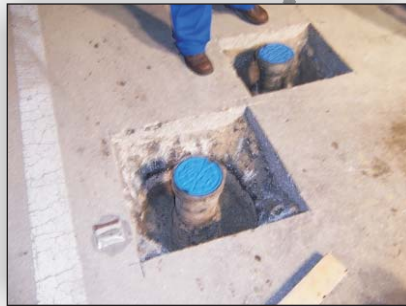
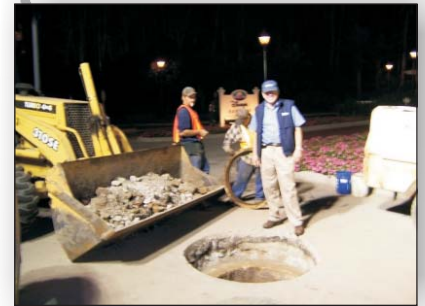
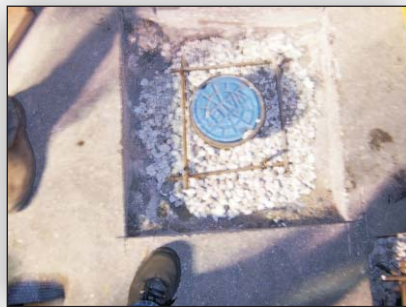
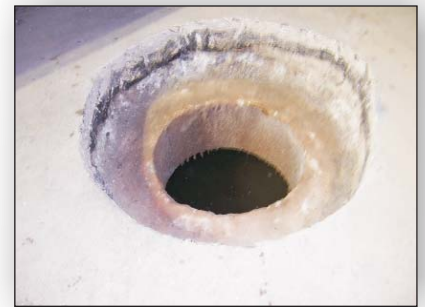
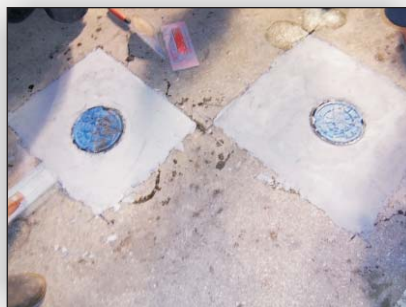
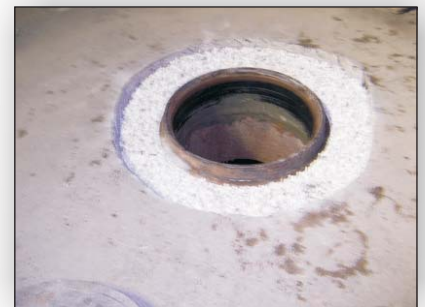
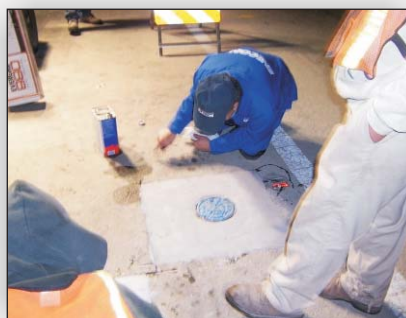
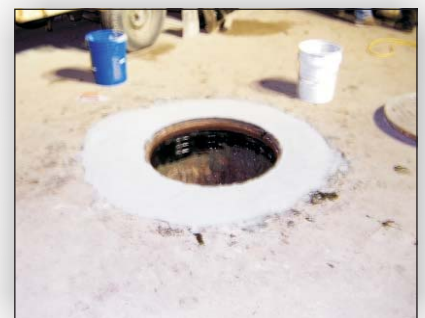
The utility purchased a few skid-loads of these materials in order to complete a number of such repair projects. These pictures illustrate just a few of them.

The Utility Engineers turned to their local ENECON Field Engineering Team who recommended our ENECRETE systems for these applications. **DuraFill** mixed with locally acquired large aggregates was first utilized to fill in the deep holes and then **DuraQuartz** was used to top-off the repair (about 1/2" thick) to provide for an extraordinarily durable road surface.
