Polish Water Treatment Plant Solves Concrete Waterproofing Problems with ENECRETE WP & WS

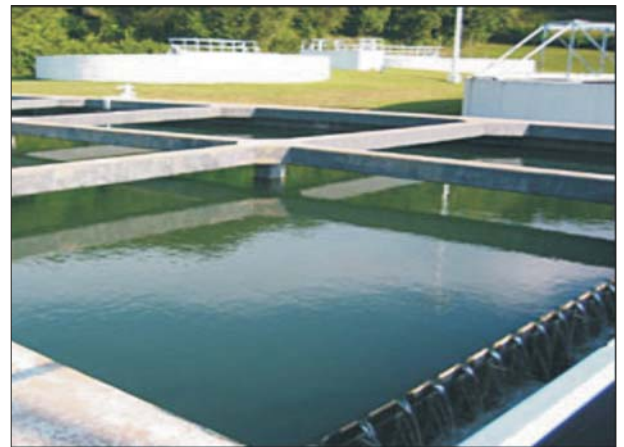
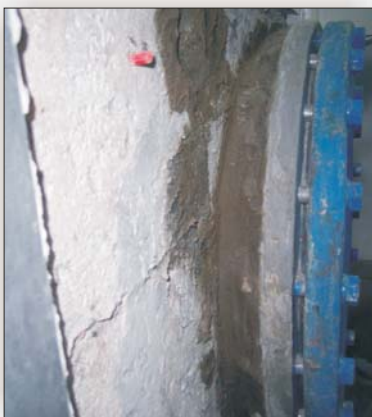
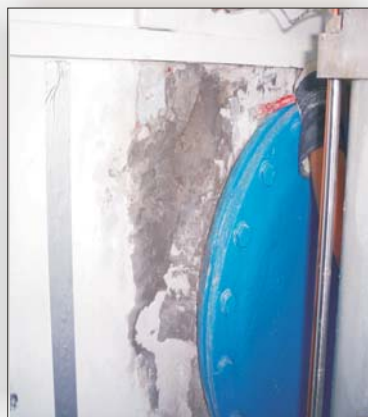
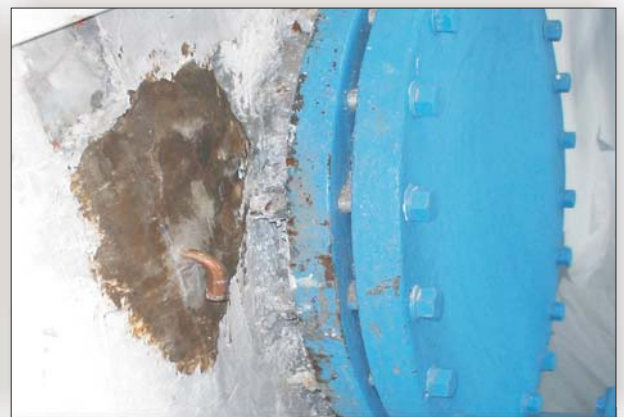
"These pictures are from a water treatment facility. There was a problem with a concrete tank used for water conditioning / purifying. This tank contains sand which helps to clean the water. After a number of years, the tank was no longer waterproof. There were many leaks, especially near the pipes that go through the tank. Our client tried to solve this

problem many times but nothing helped. We tried to help and we succeeded.

We thoroughly cleaned the surface of the wall and the pipe, dried it out and then applied SuperBond to the metal pipe. We then filled the space between the pipe and the wall (about 4 cm wide and 8 cm deep) with WP and then applied a trowelable layer of WS to smooth it out and make it look nice. All the leaks in the concrete wall were

sealed with WP and then followed by 2 coats of WS to seal the porous cement.

Everything looks nice and it really works. We are now looking at other repairs on this tank which is about 20 meters long x 20 meters wide x 10 meters high."
