## Polish Water Treatment Plant Solves Concrete Waterproofing Problems with ENECRETE WP & WS

We are pleased to reprint the following report from ENECON Poland...

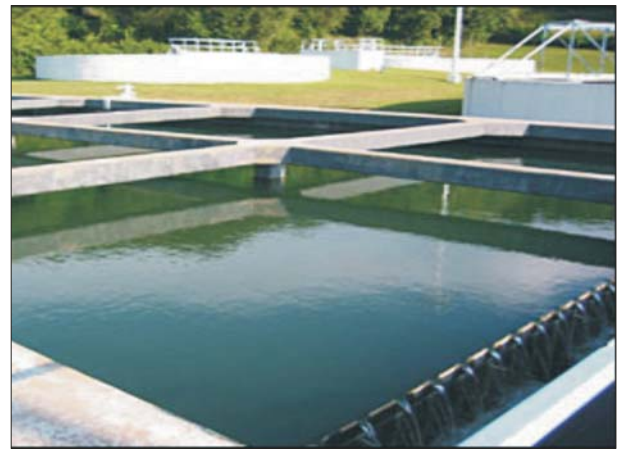
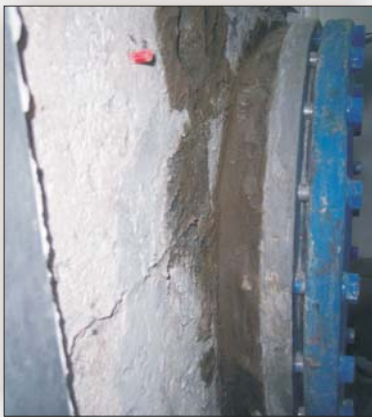
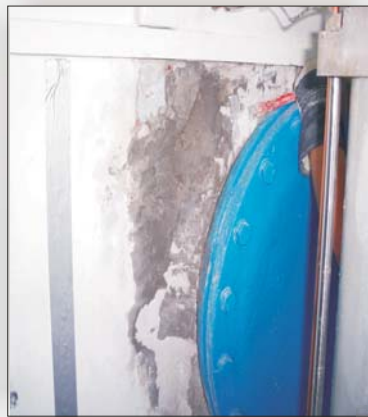
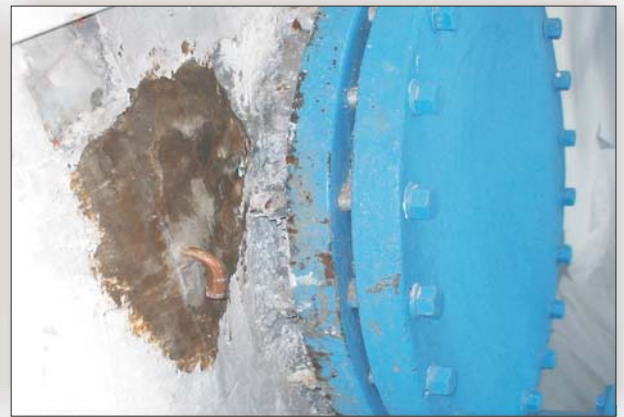
"These pictures are from a water treatment facility. There was a problem with a concrete tank used for water conditioning / purifying. This tank contains sand which helps to clean the water. After a number of years, the tank was no longer waterproof. There were many leaks, especially near the pipes that go through the tank. Our client tried to solve this

problem many times but nothing helped. We tried to help and we succeeded.

We thoroughly cleaned the surface of the wall and the pipe, dried it out and then applied SuperBond to the metal pipe. We then filled the space between the pipe and the wall (about 4 cm wide and 8 cm deep) with WP and then applied a trowelable layer of WS to smooth it out and make it look nice. All the leaks in the concrete wall were

sealed with WP and then followed by 2 coats of WS to seal the porous cement.

Everything looks nice and it really works. We are now looking at other repairs on this tank which is about 20 meters long x 20 meters wide x 10 meters high."
