DuraQuartz & CHEMCLAD XC Seal Leaks In Hospital Kitchen Floor

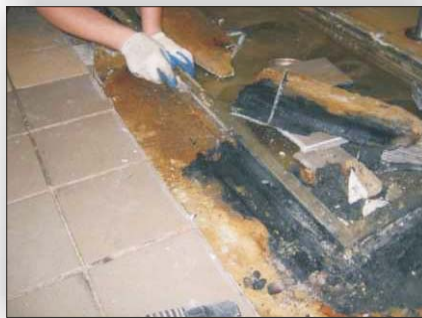
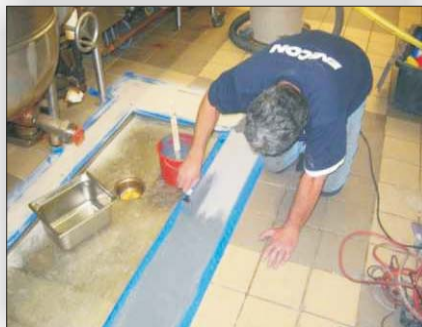
The first course of tile around the trough was carefully removed and the true source of the problem was revealed. The underlying thin set mortar and concrete was severely deteriorated by water and food acids.

After damaged materials were removed, DuraQuartz was applied to provide a smooth transition from the quarry tile floor to the rim of the trough.

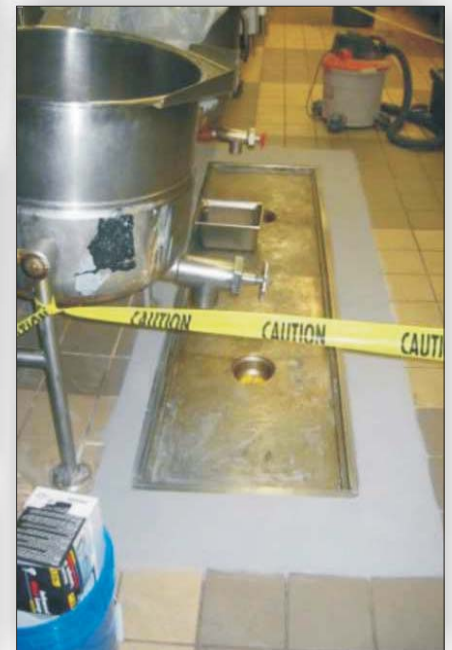
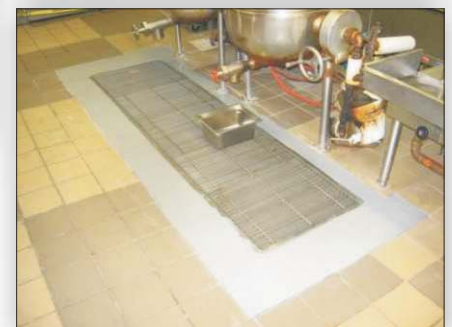
two layers of CHEMCLAD XC, incorporating an anti-slip aggregate, were applied over the DuraQuartz.
