## DuraQuartz & CHEMCLAD XC Seal Leaks In Hospital Kitchen Floor

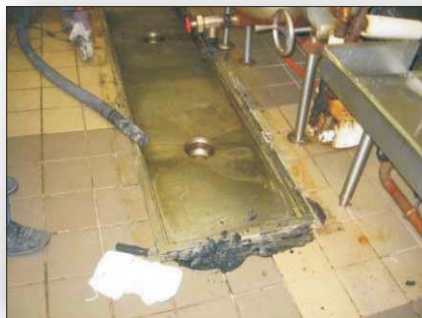
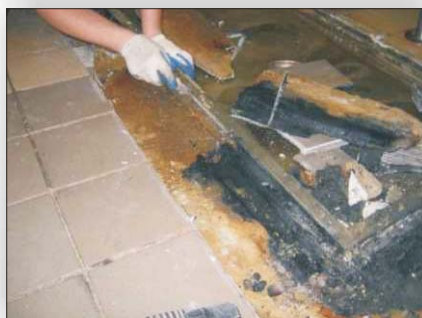
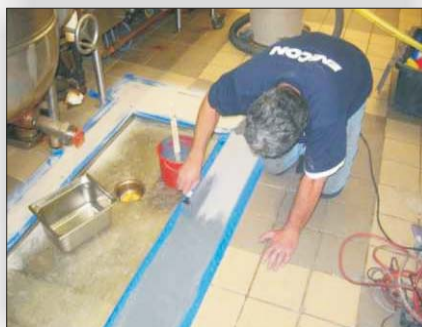
The first course of tile around the trough was carefully removed and the true source of the problem was revealed. The underlying thin set mortar and concrete was severely deteriorated by water and food acids.

After damaged materials were removed, DuraQuartz was applied to provide a smooth transition from the quarry tile floor to the rim of the trough.
