**DuraQuartz Repairs Concrete Slab at Costa Rican Beer Manufacturer**

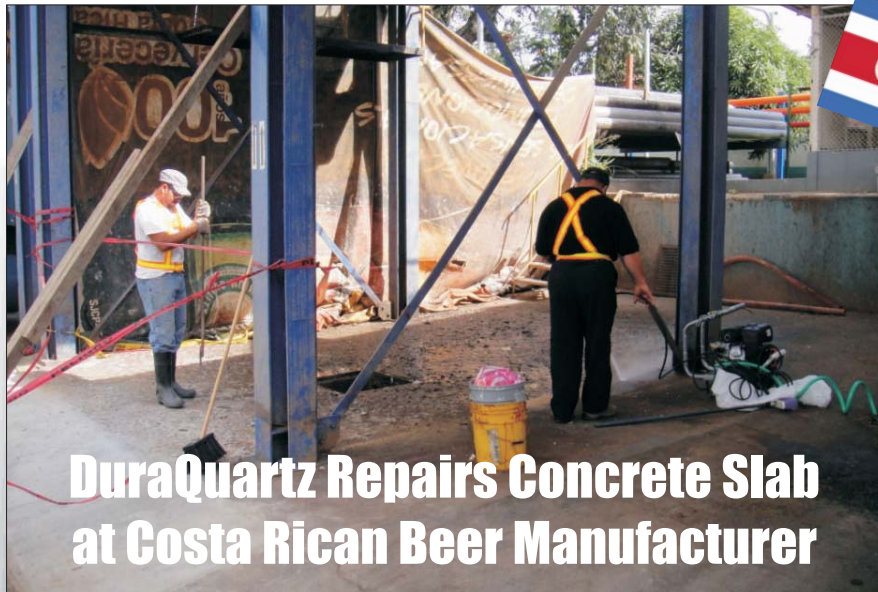
At one of the largest beer manufacturers in Costa Rica, the maintenance engineers were experiencing severe erosion and corrosion on a large concrete slab.

After many years of heavy truck traffic and corrosive

material spillage, this area had become pitted and severely deteriorated.

The local ENECON distributor was contacted to help find a fast, cost-effective and long lasting solution. It was recommended that

**ENECRETE DuraQuartz** be used to rebuild, repair and protect the concrete slab.

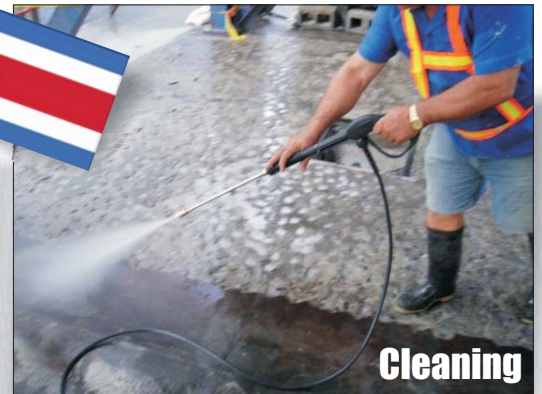
**Cleaning**

After removing any loose debris, the entire area was power washed.

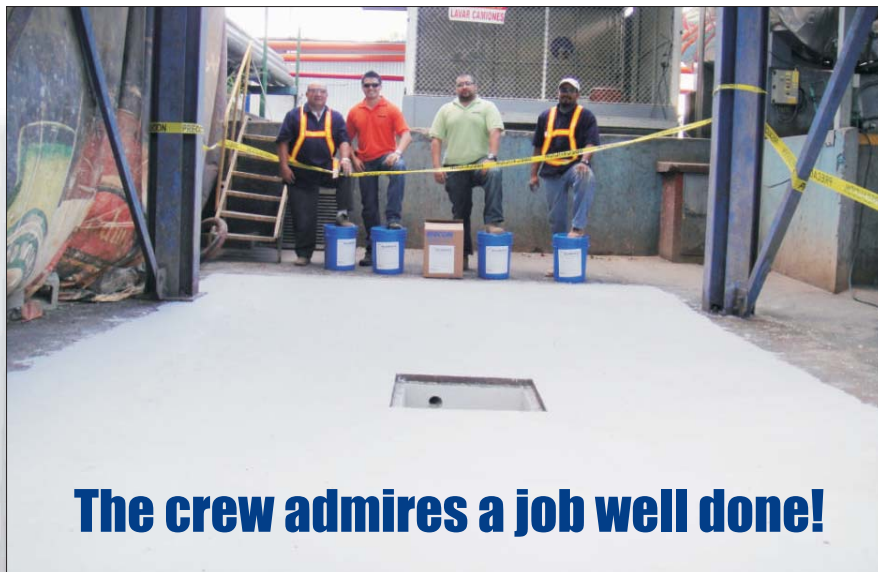
**The crew admires a job well done!**

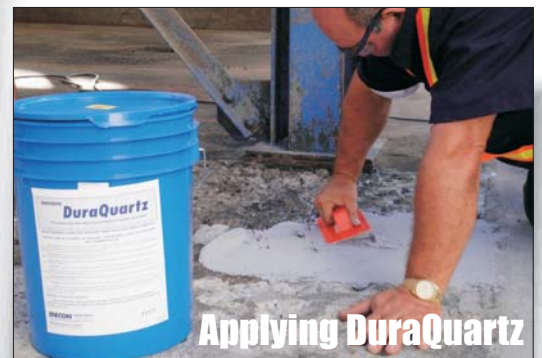
**Applying DuraQuartz**

Over 18 units of **DuraQuartz** were then used to repair the damaged area and provide excellent protection from future abuse.
