Prestigious Hospital in Montreal Solves Serious Safety Problem With a SuperBond Non-Skid System

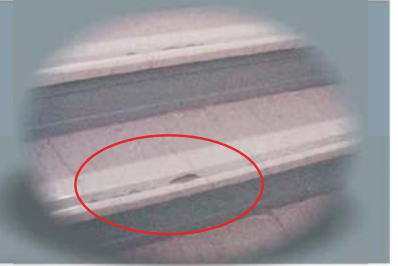
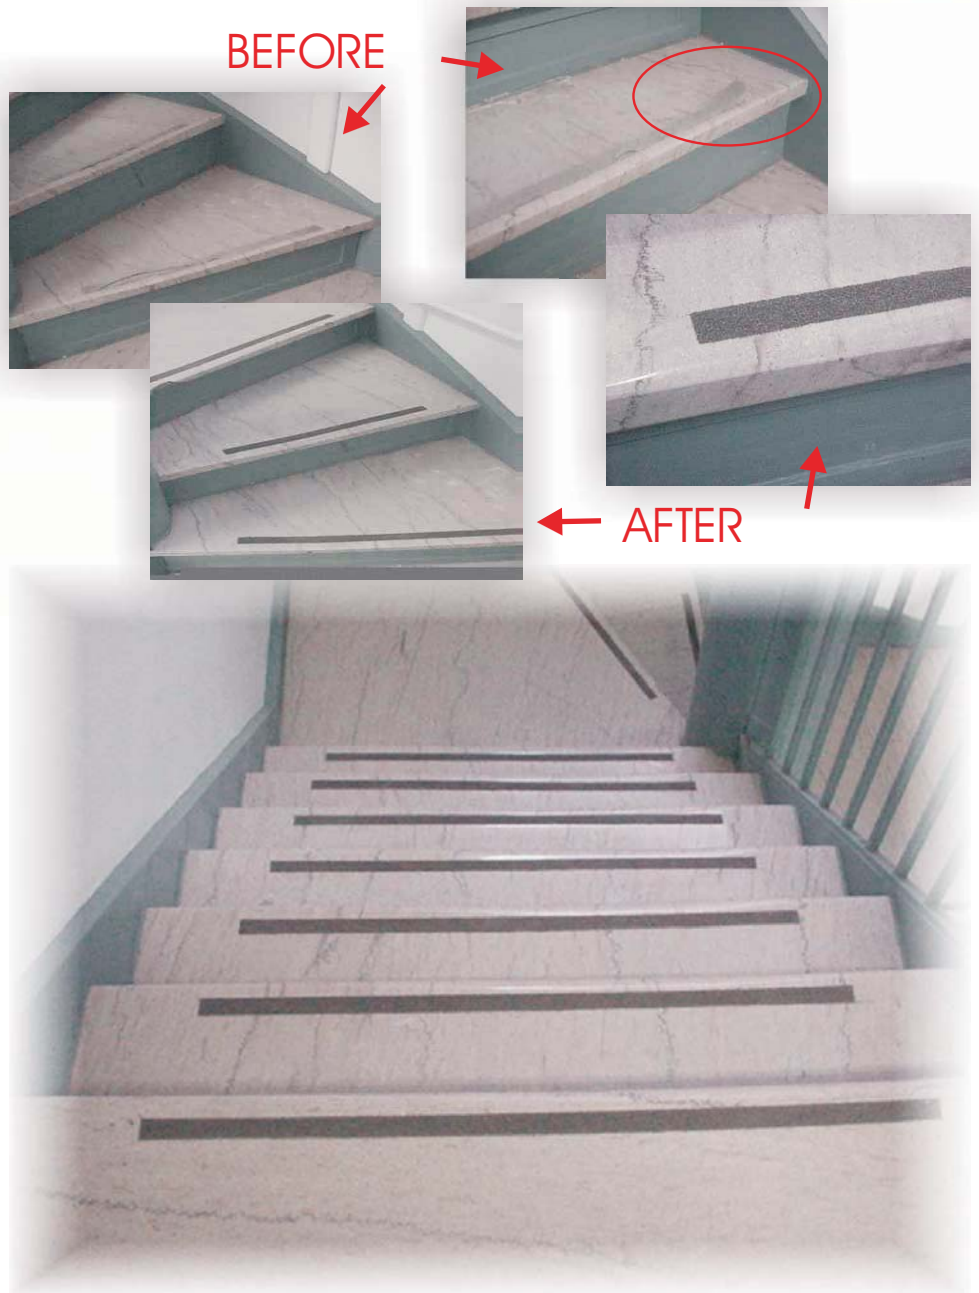
The ENECON Distributor in Montreal, Martin DeSerres, was confronted with a difficult problem. The conventional non-skid tape on these marble steps at a local hospital was constantly coming up due to the very heavy traffic on the stairs. Repeated attempts to re-apply these tapes proved ineffective.

The answer? ENECLAD SuperBond coupled with a fine aluminum oxide aggregate. After a thorough detergent cleaning, the area was dried, masked-out and SuperBond was applied. An aluminum oxide aggregate was then tamped into the SuperBond and the area was allowed to cure for 24 hours.
