## Ceramics Factory Roof in the Philippines Repaired & Protected With ENESEAL HR

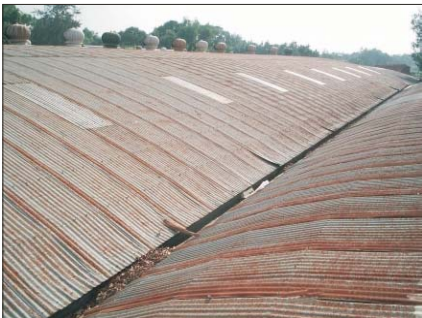
*This ceramics factory, located near Manila, had a badly corroded metal roof with hundreds of holes in it. Water would drip all over the factory during the rainy months. The factory workers would routinely squeeze into the sections of the factory where there was no water dripping!*

Note the holes in roof.

*After cleaning the roof, self-adhesive fiberglass mesh was applied over all the holes in the corrugated metal sheets. This was followed by a two-coat application of ENESEAL HR.*
