ENESEAL HR Solves Leaking Hangar Problems at Indian Airport

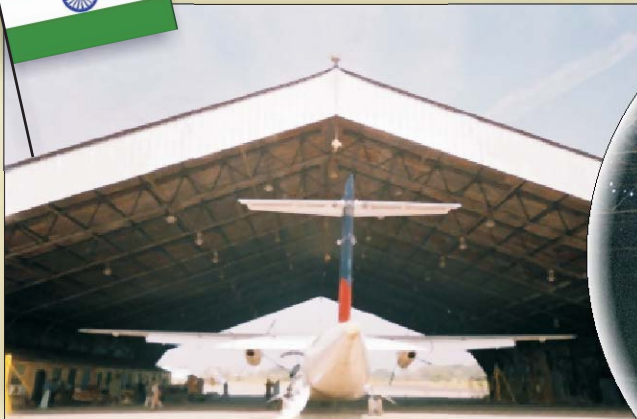
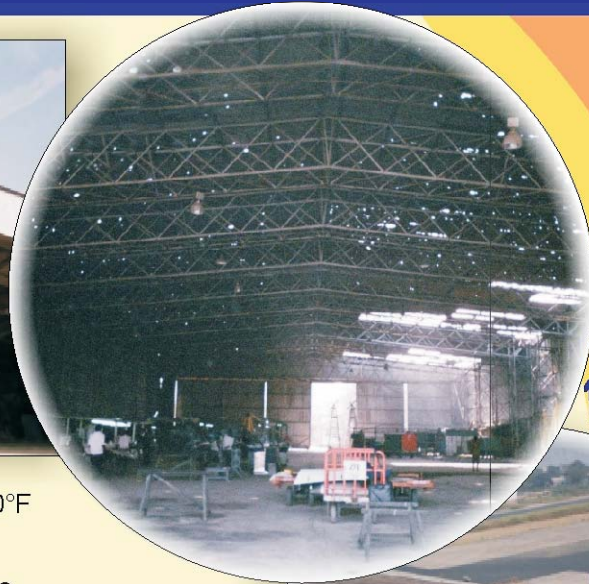
Before

Engineers at the airport in Calcutta were tired of “seeing stars” through the roof of some of their airplane hangars. Conventional tar-felting could not provide the long-term repair solution they were looking for on these corrugated metal roofs. Each hangar is over 32,000 square feet.

All roof surfaces were cleaned and a rust “converter” was used to treat rusted areas. Fiberglass reinforcing mesh was used to bridge holes in the roof with ENESEAL. Two additional coats of ENESEAL HR were then applied to completely seal the entire roof area. The project was completed in about 80 days – well ahead of the stipulated 90 day schedule.

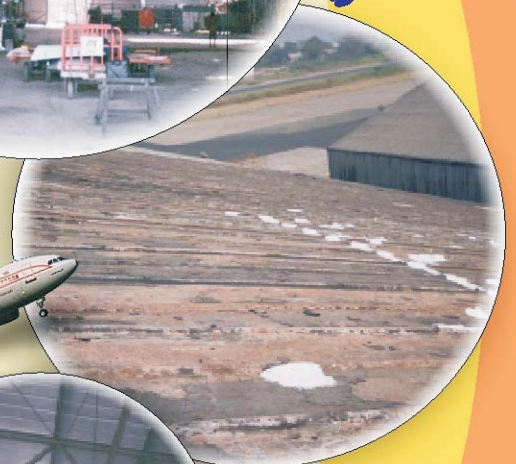
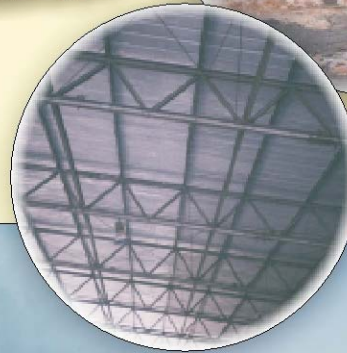
Just two days after the application was finished, torrential rains buffeted the city. To the amazement of the airport engineers, the ENESEAL coated roofs were completely water-tight. They are now in the process of tackling other problem roof areas at the airport.

After
