## ENESEAL CR Protects Venting Pipes on German Container Ships

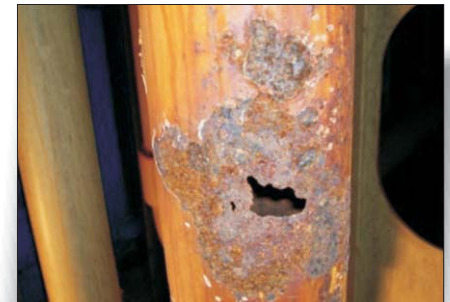
Holes caused by corrosion

Oil tank ventilation pipes located on German container vessels, part of a major German shipping line, were suffering from heavy corrosion causing pitting and massive holes in the pipes. Damage of this nature to these pipes would cause oil leaks as well as vapor leaks which could be a health risk to those on board.

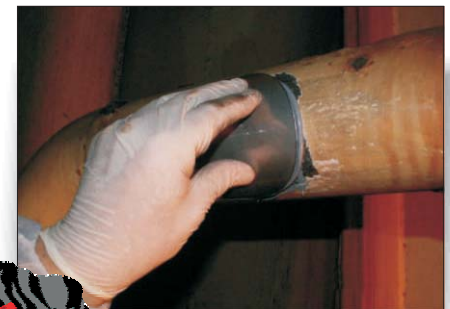
Patch applied to hole

After minimal preparation of the pipes, the large holes were repaired with stainless steel patches shaped to the contour of the pipes and adhered using DurAlloy. A first coat of ENESEAL CR was then applied. The pipes were wrapped with a fiberglass reinforcement tape and then overcoated with a second layer of ENESEAL CR creating a highly durable, corrosion resistant, elastomeric 'skin' providing extraordinary environmental protection.

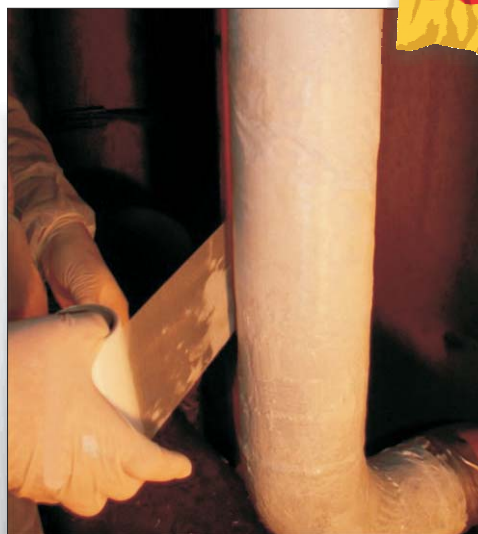
Fiberglass reinforcement tape over 1st
