ENESEAL HR Protects Apartment Building Roof In Poland

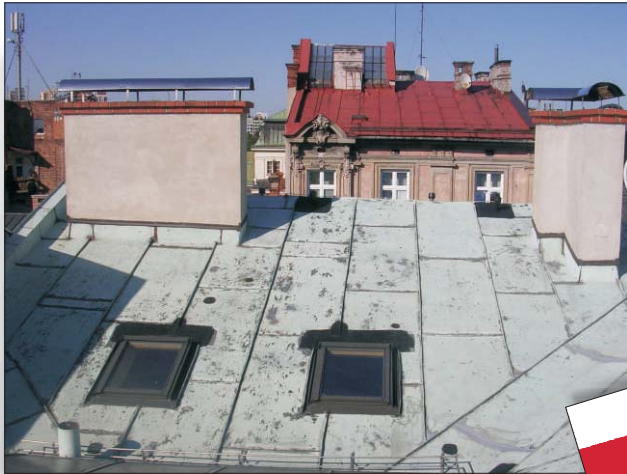
This apartment building's painted galvanized plate roof was leaking and also became very hot in the summer months making the top floor apartments uncomfortably warm.

First, all the leaking seams were repaired and sealed with **SuperBond**, **ENESEAL HR** and reinforcement cloth. Then the entire galvanized plate roof was coated with **SuperBond** and two coats of **ENESEAL HR** to provide long-term protection to the roof as well as a heat refractive surface, significantly lowering the temperature of the top floor apartments.
