DuraTough-ing Out
CAVITATION
ATTACK

A hydroelectric plant in British Columbia, Canada, has found the use of our ENECON FLEXICLAD DuraTough to be the best method of repairing and protecting these Francis Turbine Runners from severe cavitation attack.

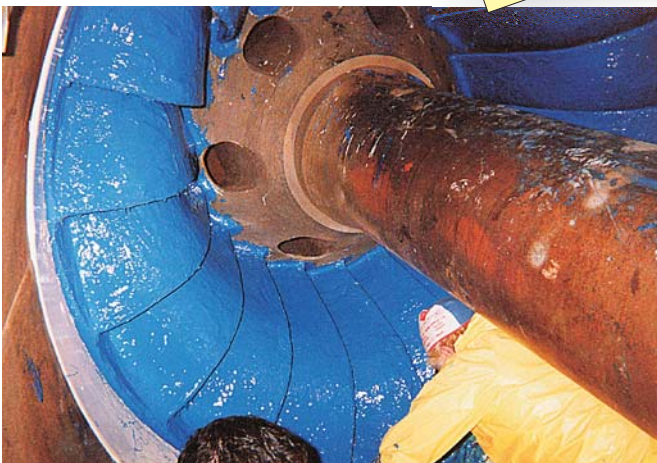
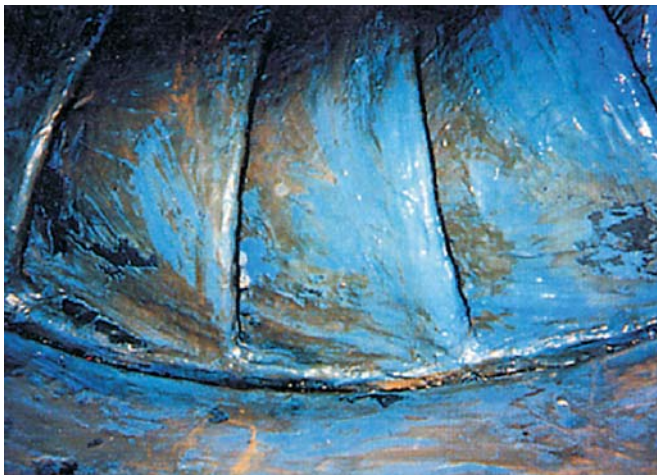
The repair, and the DuraTough DL, had performed beyond expectations.

The units were repaired by first using CeramAlloy CP+ to rebuild the deeply damaged areas back to the original surface contour. This was followed by the application of two coats of the FLEXICLAD DuraTough DL system to completely resurface the runners.
