DuraTough Solves Vacuum Leak Problems on Main Steam Condenser at Major Power Plant

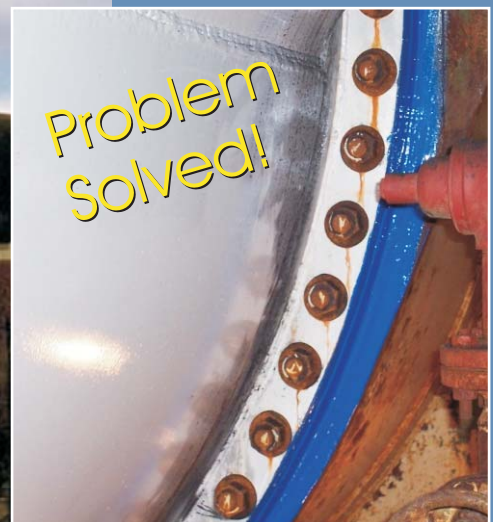
This large power station located in the Northeastern United States experienced serious air leakage in their main steam condenser. The source of the leaks was traced to the tube sheet to shell to hot well sandwich joints located where the inlet and outlet water boxes are bolted to the tube sheets/condenser shell.

The ENECON Northeast Engineering Team proposed to prepare the face of the bolted joints by

abrasive blasting to remove rust and provide for the best possible adhesion of the DuraTough DL system.

DuraTough Primer was applied, followed two coats of DuraTough DL with a fiberglass reinforcing mesh incorporated into the DuraTough DL.

Approximately 1/8 inches of DuraTough was applied to provide complete sealing to the joints.
