MILESTONE RESULTS FROM THE NEW A/V

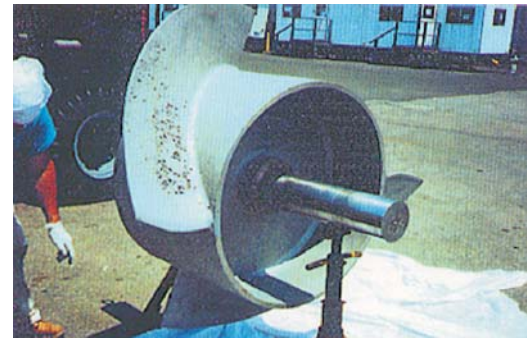
Two days later, John was at the plant to conduct a technical presentation for the maintenance personnel. A few days after the presentation, having been completely impressed with the products and tech services available from ENECON, one of the plant's Maintenance Techs called for some METACLAD CeramAlloy to repair an intake pump that had been severely eroded/corroded.

The pump impeller, after grit blasting.

The repair was scheduled for the following Sunday. After grit blasting first on Saturday and again on Sunday morning, the repair was carried out by initially rebuilding the deeply eroded areas with CeramAlloy CP+. This was followed by the

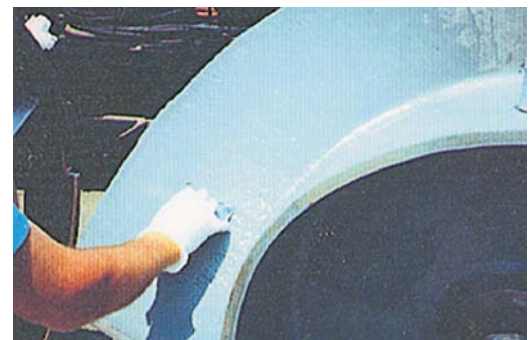
Rebuilding with CeramAlloy CP+

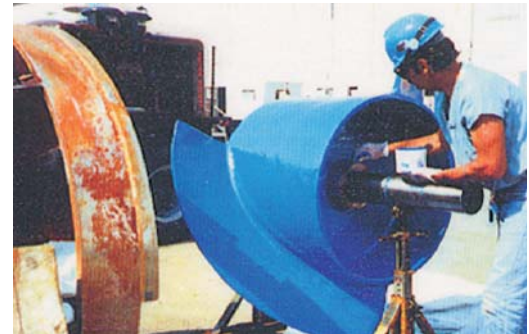
Putting the finishing touches on the impeller.

application of two coats of CeramAlloy CL+ to completely protect the components.

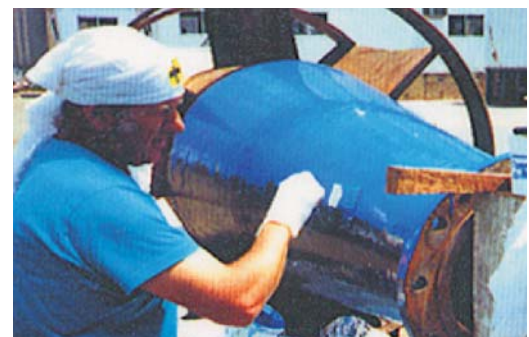
Applying CL+ to one of the diffuser components.
