## MILESTONE RESULTS FROM THE NEW A/V

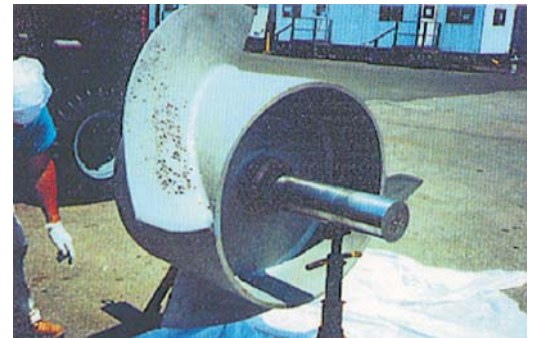
Two days later, John was at the plant to conduct a technical presentation for the maintenance personnel. A few days after the presentation, having been completely impressed with the products and tech services available from ENECON, one of the plant's Maintenance Techs called for some METACLAD CeramAlloy to repair an intake pump that had been severely eroded/corroded.

*The pump impeller, after grit blasting.*

The repair was scheduled for the following Sunday. After grit blasting first on Saturday and again on Sunday morning, the repair was carried out by initially rebuilding the deeply eroded areas with CeramAlloy CP+. This was followed by the

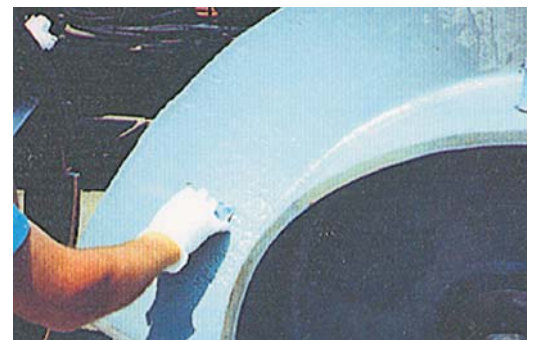
*Rebuilding with CeramAlloy CP+*

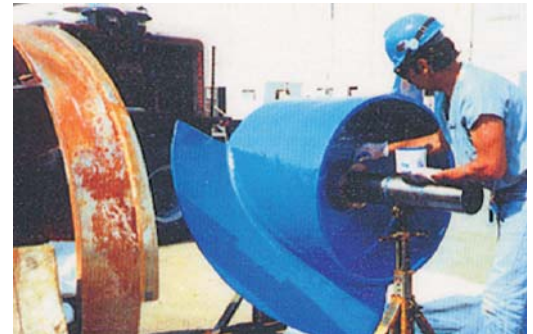
*Putting the finishing touches on the impeller.*

application of two coats of CeramAlloy CL+ to completely protect the components.

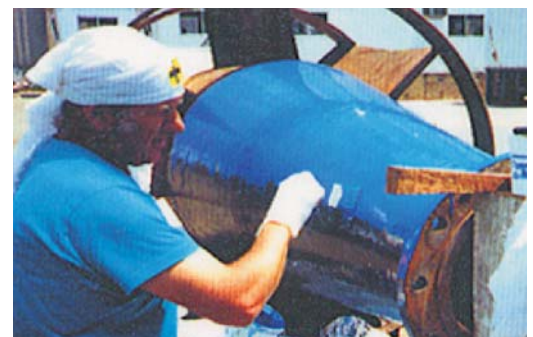
*Applying CL+ to one of the diffuser components.*
