CeramAlloy Used for Critical Pump Repairs At Nuclear Station... Saves \$90,000 in Replacement Costs!

The plant engineers at a nuclear power station located in the Pacific Northwest in the US discovered severe erosion/corrosion wear on the impeller, the suction bell and the diffuser bowl of a large submersible pump. This tower make-up water pump supplies water from the river to the cooling towers.

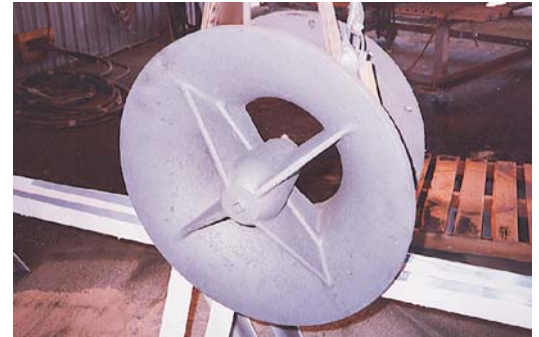
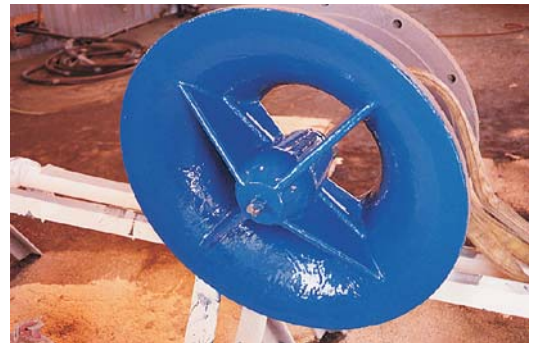
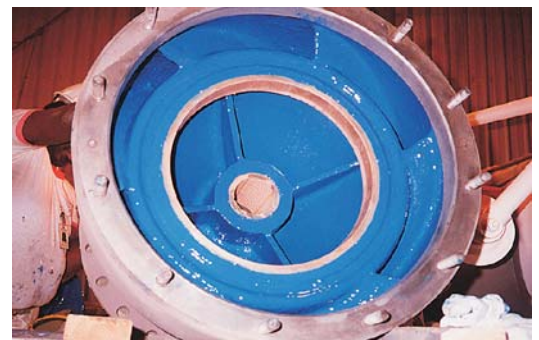
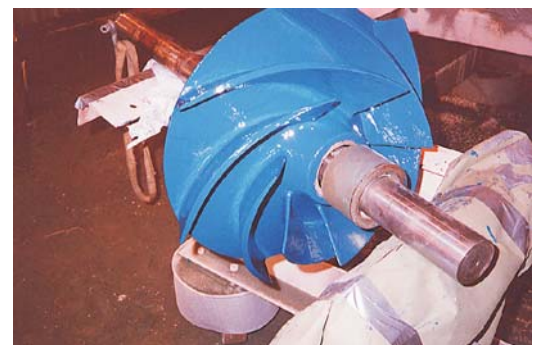
Sand and silt entrained in the river water accelerated the erosion damage to the pump while electrolysis problems had also accelerated the corrosion damage.

All the pump components were first abrasive blasted to a 3-4 mil profile. All pitted areas on the diffuser bowl and the suction bell were then filled using CeramAlloy CP+ followed by the application of two coats of CeramAlloy CL+. The impeller, due to the rough surface, was coated with brush-applied CP+ to fill in as a base for the subsequent two coats of CL+.
